Causal Analysis on the Lining Exfoliation and Treatment Design of an Operational Tunnel

Abstract: According to the actual situation of the secondary lining of a expressway tunnel in Chongqing, this paper analyzed the specific reasons for lining exfoliation with corresponding test reports. According to this, a quick treatment scheme for lining exfoliation is proposed, which can make the treatment timely and effective, and suggestions for treating similar diseases in tunnels are put forward, which can provide reference for similar projects.

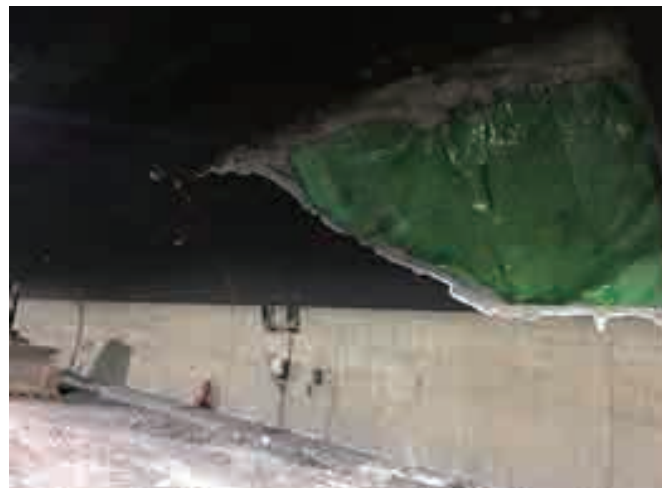
In February 2017, the secondary lining of the K22+356 ~ K22+368 segments of the right tube of the tunnel partially exfoliated. In addition to the partial exfoliation of secondary lining, there were 13 obvious longitudinal faulting of slab ends on the secondary lining of the segments, and the segments with faulting of slab ends were through cracks, extending along the secondary lining of the mold (Figure 1-3).

Figure 1. Partial exfoliation of the tunnel secondary lining

(1) According to the inspection report, in addition to the partially exfoliated secondary lining in the segments, there are 13 obvious longitudinal faulting at slab ends in the secondary lining. The faulted segments are through crack, which spans the secondary lining of the entire mold, and there is also risk of secondary linings falling off. Therefore, due to construction technology and other reasons, there are suspected concrete construction cold joints on the secondary linings of the side wall and arch waist (the construction cold joint runs through the single-mold concrete longitudinally), which destroys the overall stressed structural system of the secondary lining and is an important reason of secondary linings falling off.

(2) Due to the simultaneous occurrence of two parallel longitudinal cracks or construction cold joints on the side wall and the arch waist, the secondary lining structure from the vault to the arch waist may topple and fall off after the following actions:

(3) According to the inspection report, there are 39 voids behind the secondary linings within the survey line in the right tube, among which 29 voids were found in the vault survey line; 9 voids were found in the arch waist survey line; and 1 void was found in the side wall survey line. There is a cavity between the partial secondary lining and the initial support, which makes the secondary linings bear uneven forces.

(6) Repair the local area where the secondary lining has fallen off:

1) Cleaning, chiseling hairs off, and planting reinforcement on the interfaces of existing linings (three sides);

2) Spray CF35 accelerated steel fiber concrete, reserve the connecting bars for the later shotcrete, and proceed to the next step after it reaches the design strength.

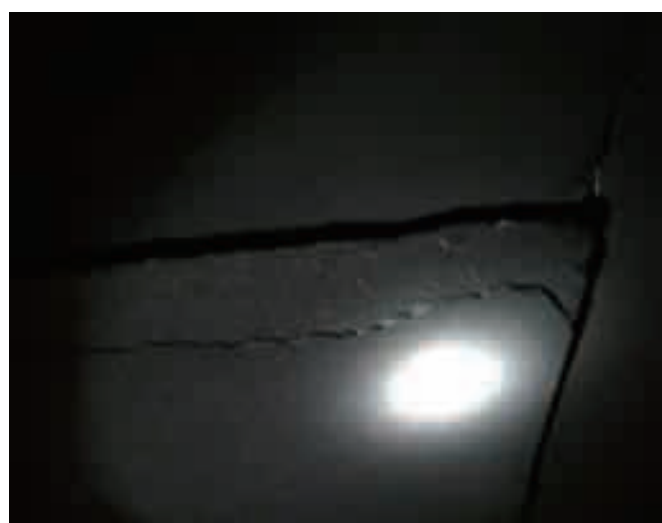
Figure 2. Faulting of slab ends on the secondary lining on the right side of vault of the k21+241 segments

(1) The K21+259 ~ K21+271 (designated pile serial number) segments are fault by 6cm, the crack width is 4cm, and the depth is about 60cm. It is a through crack and extends along the entire secondary lining.

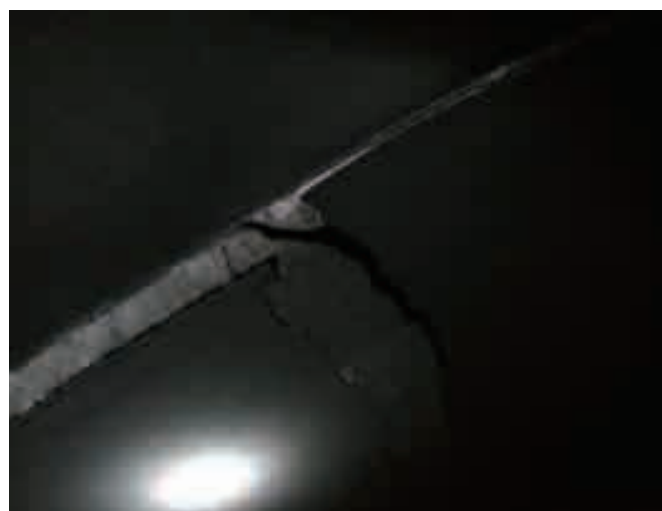
Figure 3. Faulting of slab ends on the secondary lining on the right side of vault of the k21+275 segments

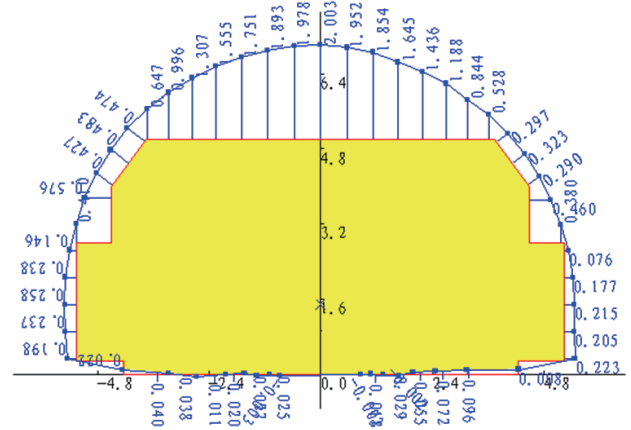
There are a total of 35 lining segments in the key disease segment inspection. The driving boundary of the inspected segments was not invaded, but the distance from the contour line to the local (near the arch line) measurement point is small.

Figure 4. Measured lining boundary contour map of cross-segment k2+485

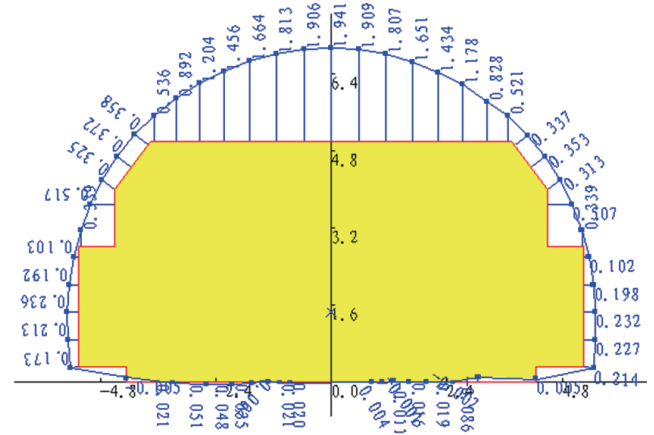
Figure 5. Measured lining boundary contour map of cross-segment k2+526
