Research on the Inspection Method of Chimney Appearance and Masonry Material Performance

This case project is a chimney built in the urban area for about 30 years. The residential area near the structure is crowded, and the safety inspection of the chimney is urgent. The inspection content in this case is the integrity of the chimney appearance, the tilting and the strength of the load-bearing material.

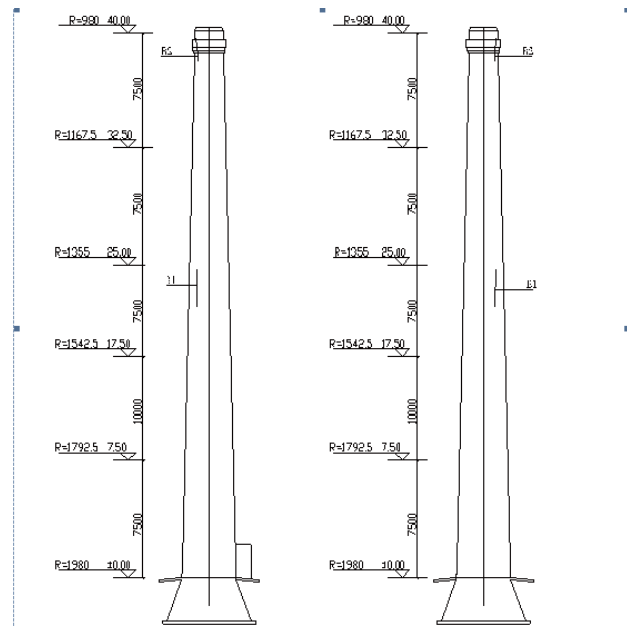
Figure 2. Illustration of chimney cracks

The overall conditions of the pipe are as follows: there are some small cracks on the top, while the rest is intact.

Leica TCR802 Total Station was used to survey and map the crack positions. The detailed conditions of crack surveying and mapping are shown in Table 1, and the schematic diagram of crack distribution is shown in Figure 2.

longitudinal cracks on the top of the chimney, the longest crack length was less than 3 meters, and the crack width was less than 2cm. The interior of the pipe was lined all the way to the top, and the condition was good, with no significant cracks or damage found. The external ladders of the chimney

(1) The cracks at the top of the chimney have a small coverage and a small gap width, which do not have a major impact on the safety of the structure. If no reinforcement measures are taken, the cracks will continue to develop under the influences from the external environment. It is recommended to repair the cracks. The repair method is suggested as follows:

① Reinforce the cement mortar surface with a

reinforced steel mesh of 8mm in diameter and spacing not more than 200mm (the thickness of the cement mortar surface is 50mm and the strength is M10), and grout the cracks with pressure grouting cement mortar. ② Along the length of the crack and within the range of 1m up and below, use a 60X5 flat iron to set up hoops along the pipe every 0.5m. Select hoops made of flat iron of the same model, and add fixed screws at both ends. The treatment method inside the crack is the same as step 1. The repair of the chimney should be entrusted to a qualified company. During the repair, climbing the bricks around the cracks at will is not allowed, and the repair personnel must take safety protection.
