An Evaluation of Standards in Open Spaces for Mobility Impaired Users: The Example of Istanbul's Çirpici Community Gardens

Publication date: October, 2019

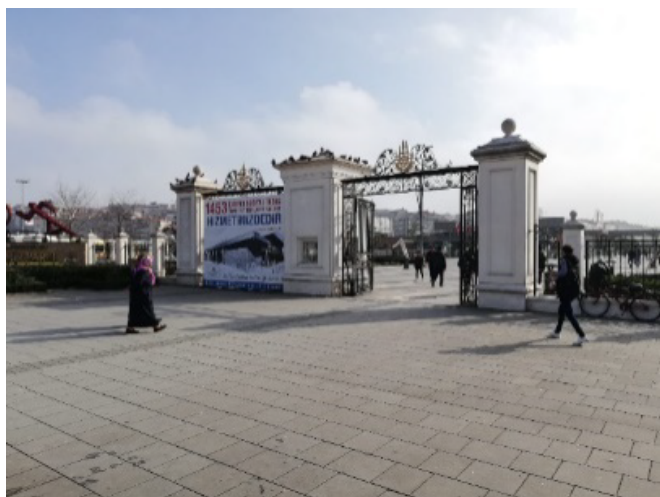
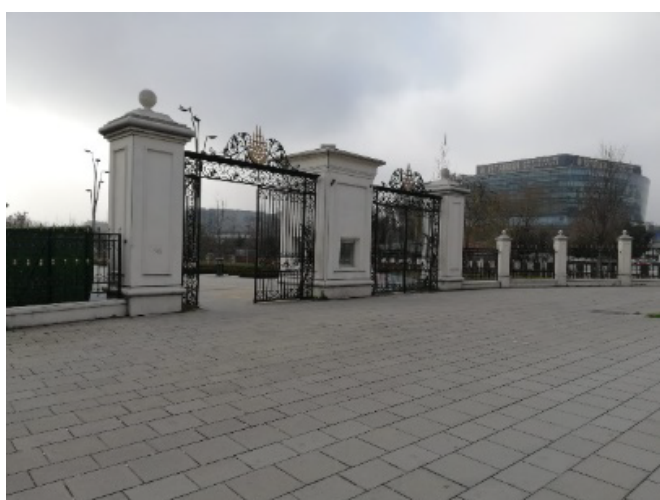
Figure 4. Zone 1 Entrance 1 (Photo 1)

Figure 5. Zone 1, Entrance 2 (Photo 2)

There are two separate entrances to the area (Figures 4 and 5). It was observed that as there is no difference in the surface elevation, wheelchair users can enter with ease.

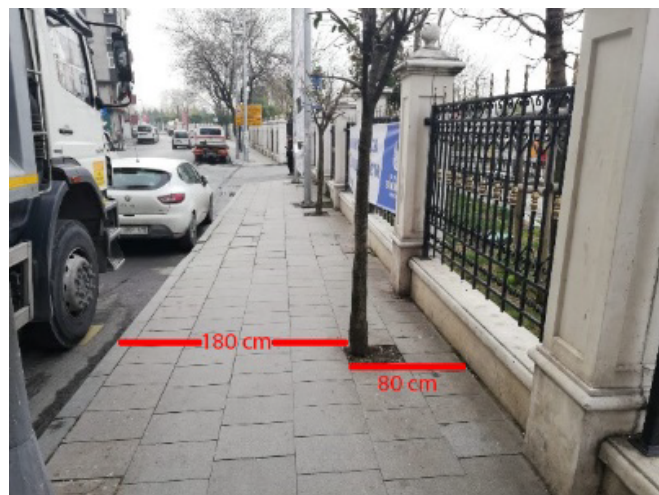
In Zone 1, as indicated in Figure 6, the pavement was measured and found to be 260 cm in width and 15 cm in height, with a cross slope of 1% and a longitudinal slope of 3%. The joint gap of the paving was 2mm. According to the standards, the width of the pavement must be at least 150cm, the paving height (from the road paving) at least 3cm and at most 15cm, the cross slope at most 2% and the longitudinal slope at most 5%; the paving joint gap should be at most 5mm. As such, the pavement was observed to be suitable for wheelchair users. In order that the paving material would not be slippery

for wheelchair users in wet weather, slip-resistant material was chosen. When the trees planted along the pavement were examined, they were found to be suitable at a pavement width of more than 200cm (Figure 6).

Figure 6. Zone 1, pavement around the gardens 1 (Photo 3)

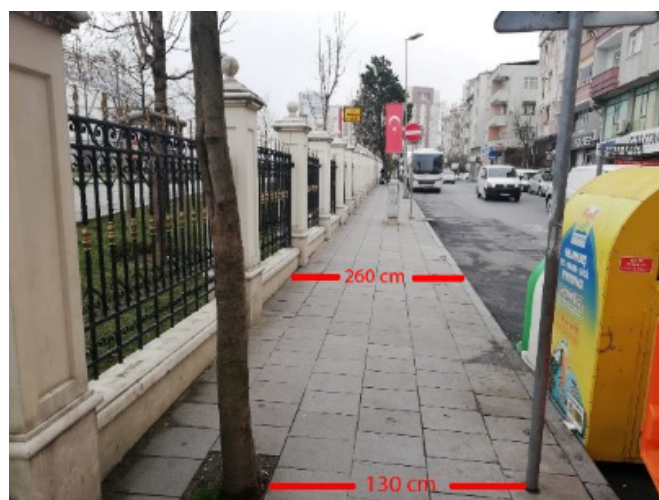
The trees and traffic signs on the pavement do not pose an obstacle to the passage of wheelchairs, as shown in Figure 7. It was observed that there was no protective barrier constructed at the kerb to prevent cars from parking on the edge of the pavement (Figure 7)

Figure 7. Zone 1, pavement around the gardens 2 (Photo 4)

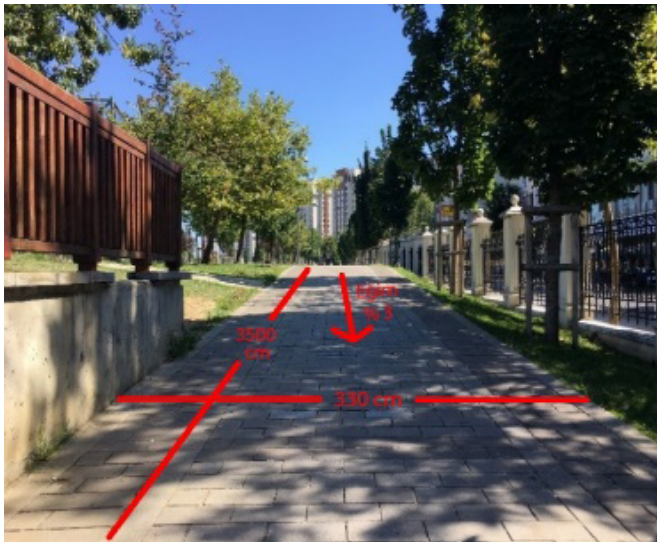
Figure 9. Zone 1, location of needed rest area on pedestrian road (Photo 6)

In the part of the study area shown in Figure 10, the width of passage on the pedestrian path was measured to be 330cm, and the slope of the pedestrian path a maximum of 3%. In this area the slope of the pedestrian road is suitable; however, because the length of the road is more than 10m, for every 10m there should be a 150 x 150 cm landing platform and rest area, and this is not present. As such, it is unsuitable for wheelchair users (Figure 9).

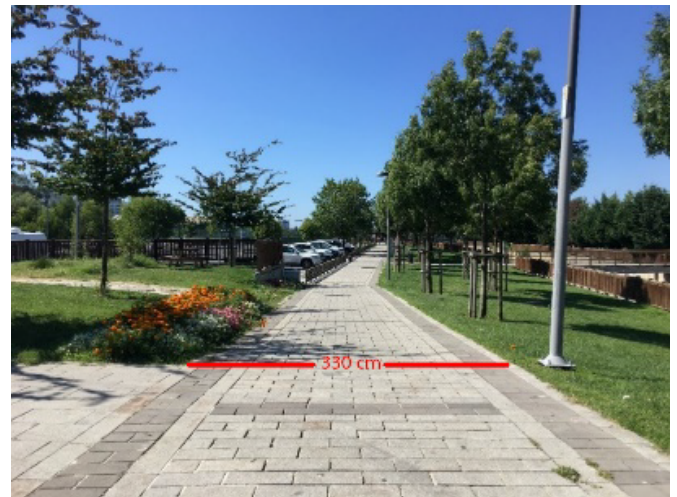
Figure 10. Pedestrian road in Zone 1 of the gardens (Photo 7)

The road shown in Figure 10 has a passage width of 330cm, and its slope close to zero. The spacings of the drainage grating on the road were 13 mm, in line with standards. The joint gaps in the material are such that they do not pose a problem for wheelchair users passing over them. The protective kerb at the edges of the ramp was 5cm. According to the standards, it was observed to be suitable for wheelchair users.

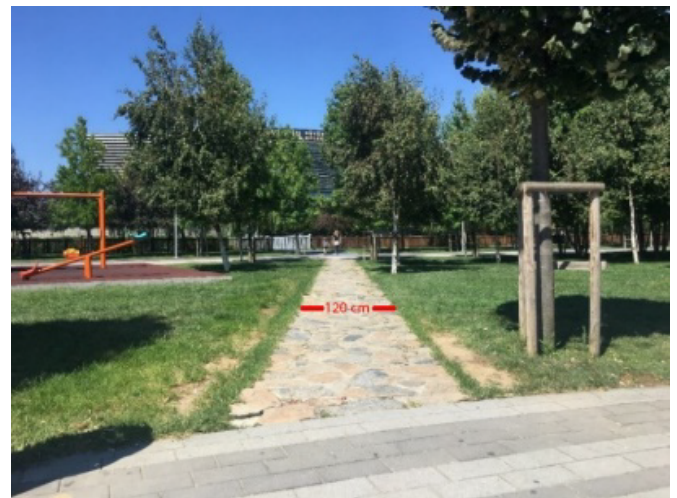
Figure 11. Side road in Zone 1 of the gardens (Photo 8)

in Figure 11, had a width of 120cm and a 3% slope. The paving material of the pedestrian road is unsuitable from the point of view of a wheelchair user. The road allows a wheelchair user and an unimpaired individual to pass one another easily; however, the paving was determined to be unsuitable according to the standards.

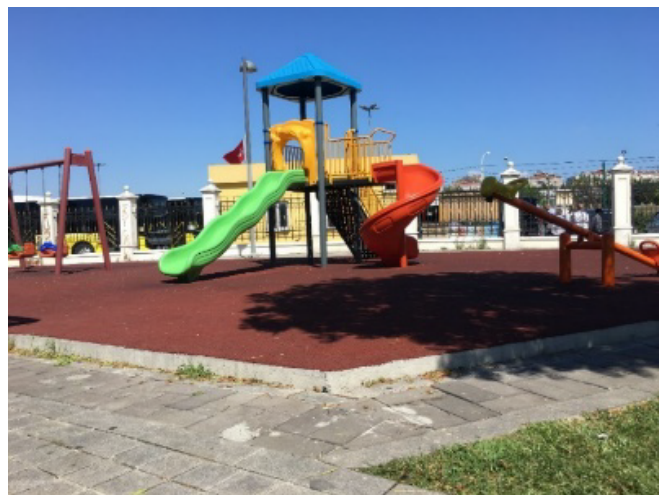
Figure 15. Zone 1, entrance to children's playground without ramp (Photo 12)

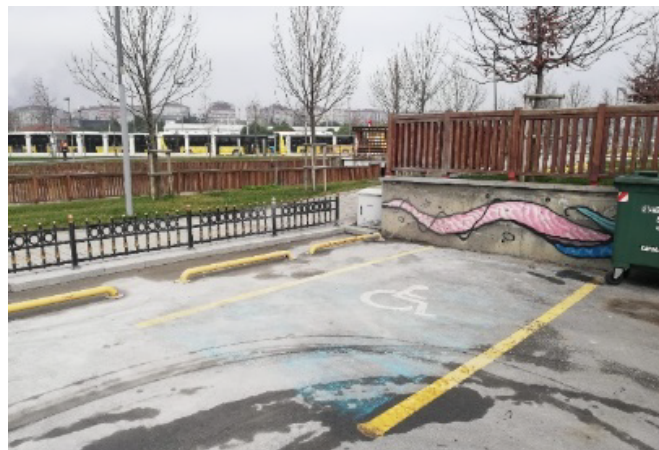
Figure 16. Zone 1, disabled parking area 1 (Photo 13)

Regarding the suitability of the parking areas for disabled users, the elevation level was +3.00 cm, the width of the parking space 390cm, and the gap between parking spaces 120cm to allow for wheelchairs. Disabled parking signs have been made on the ground. Considering the standards, these conditions are suitable for wheelchair users (Figure 16).

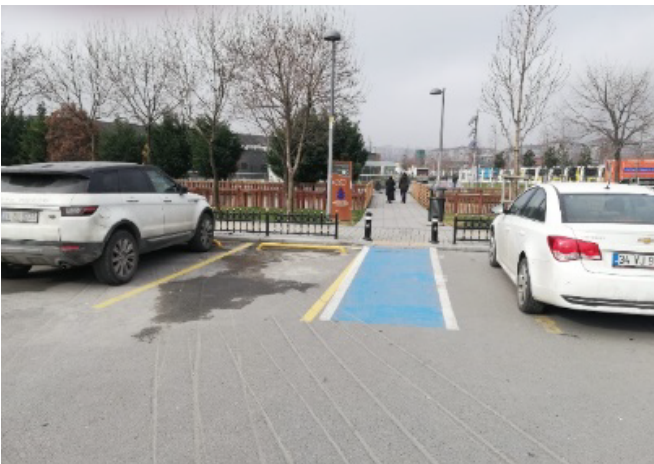
Figure 19. Zone 1, disabled exit road from parking area (Photo 16)

The entrance to the parking area does not pose a problem for wheelchair users, and the space for getting tickets is also suitable (Figure 18). Within the parking area indications of direction are inadequate; are no existing signboards to guide disabled users. The 2% slope to get to the pavement from the parking area is suitable for wheelchairs. No special space has been set aside for disabled users to access the carriageway. It was observed that in the car park, there is an insufficient number of disabled parking spaces (Figure 19).

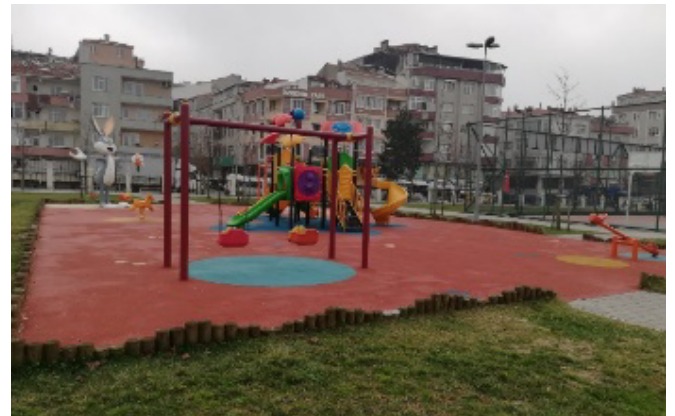
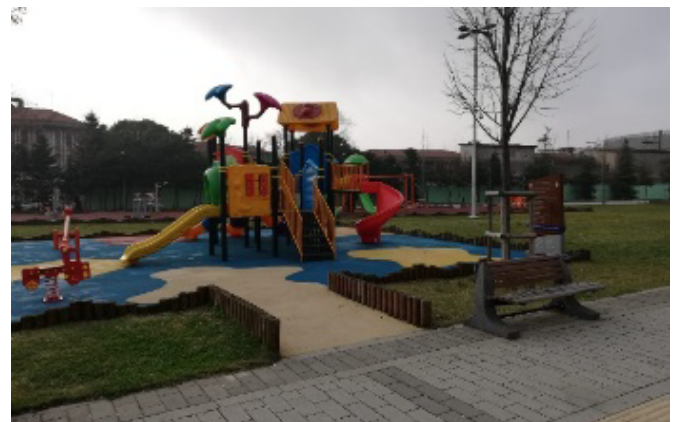
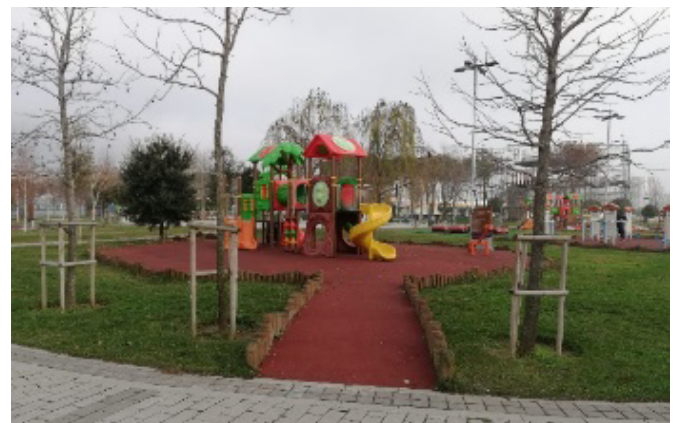
In Zone 1, there is a total of six children's group play areas. Figures 20-22 show children's play equipment with slides and swings that is not oriented to the needs of physically disabled users.

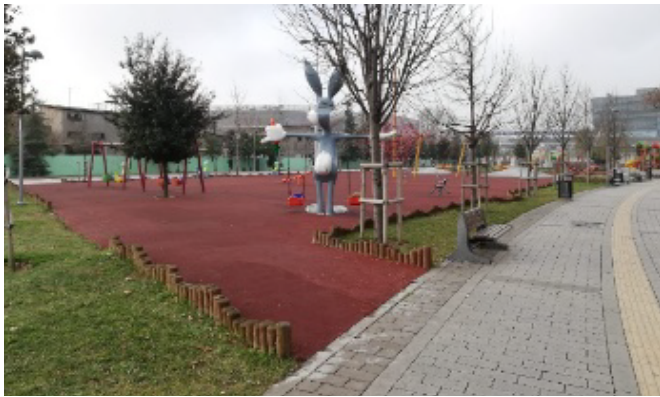
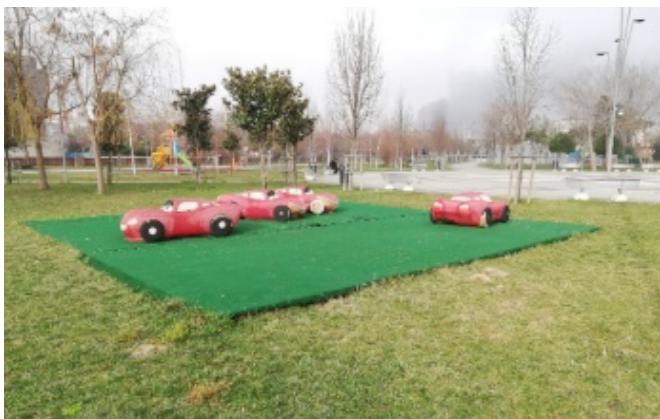
The other children's group play areas include frames with swings and play areas with children's cars, as seen in Figures 23-24. In the swing areas, there are no specially designed swings for wheelchair users. For wheelchair users to use swings, the size must be suitable for wheelchairs, and secure swing equipment is needed. Because children's areas with cars must enable disabled users to use them with assistance from others, these areas were inadequate.

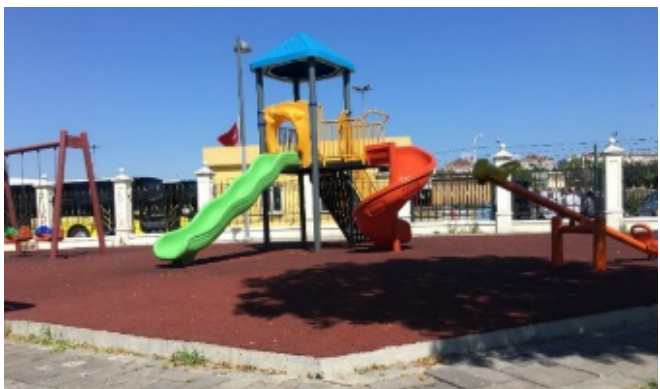
Figure 26. Entrance to children's playground, ramp not constructed (Photo 12)

Figure 26 shows that there are no ramps at all at the entrance to the children's play area, so it is unsuitable for wheelchair users.

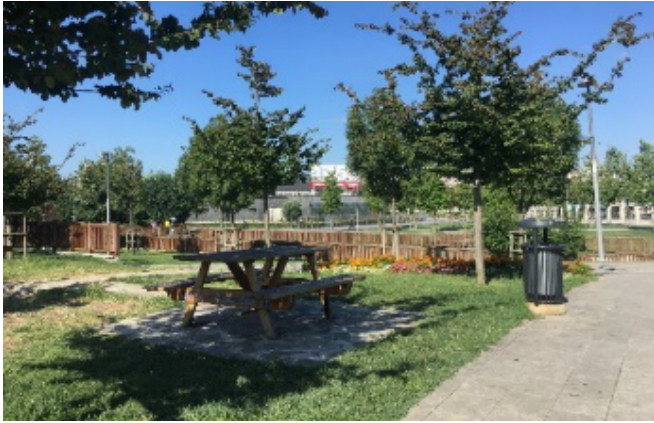
Figure 36. Zone 1, tables with benches (Photo 32)

The benches with picnic tables in this area are unsuitable for wheelchair users (Figure 36). The height of the openings of trash cans from the ground is within the standards, at 100cm. The trash cans are spaced correctly, but the distance from the edge of the

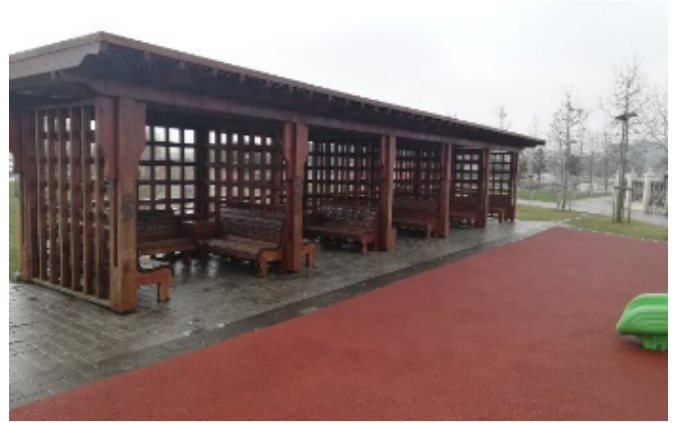
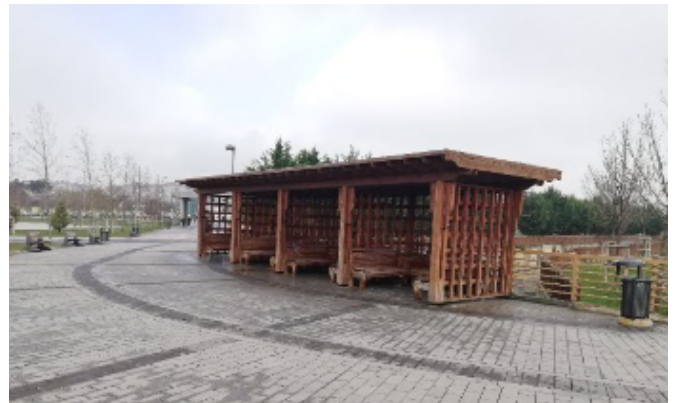
Figures 40 and 41 show that there is no space set aside under overhead protective covering elements for wheelchair users.

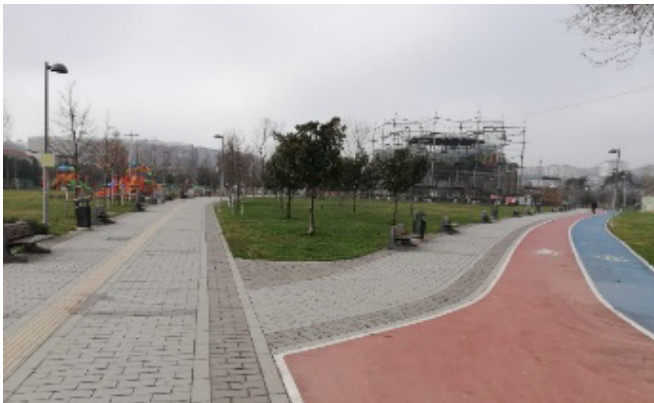
Figure 37. Zone 1, trash cans (Photo 33)

pavement is unsuitable (Figure 37).

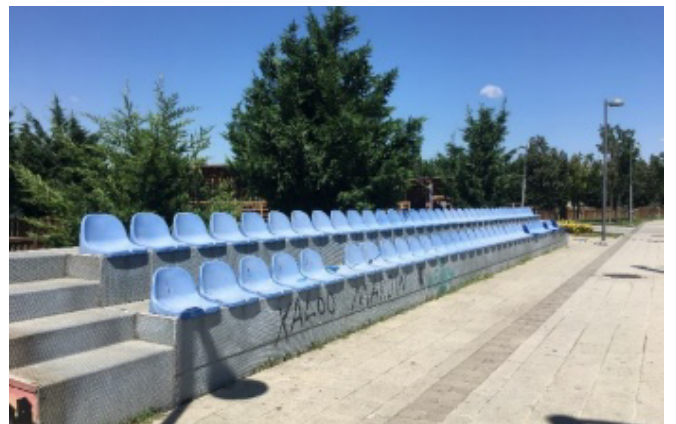
Figure 42. Zone 1, stands (Photo 38)

According to the standards, the area set aside for seating elements should leave a 1.20 x 1.20m space. Figure 42 shows that such a space has not been left at the stands for wheelchair users. This area is unsuitable for wheelchair users.

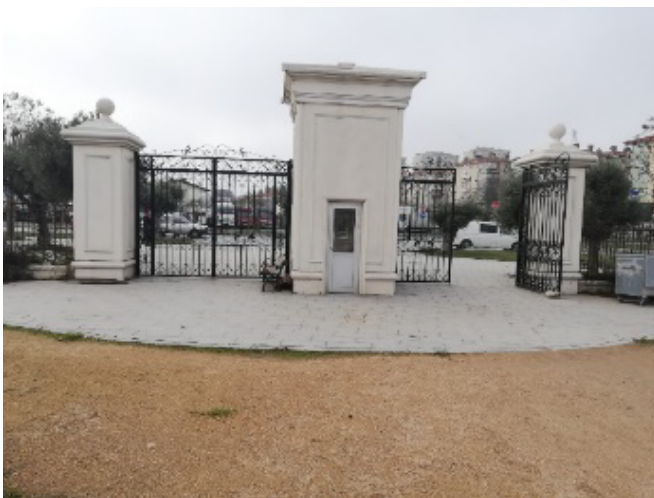
Figure 44. Zone 2, entrance gate (Photo 1)

In Zone 2, there is one entrance gate. The ground in the front area past the entrance is made of compressed sand and this creates difficulties for wheelchair users (Figure 44).

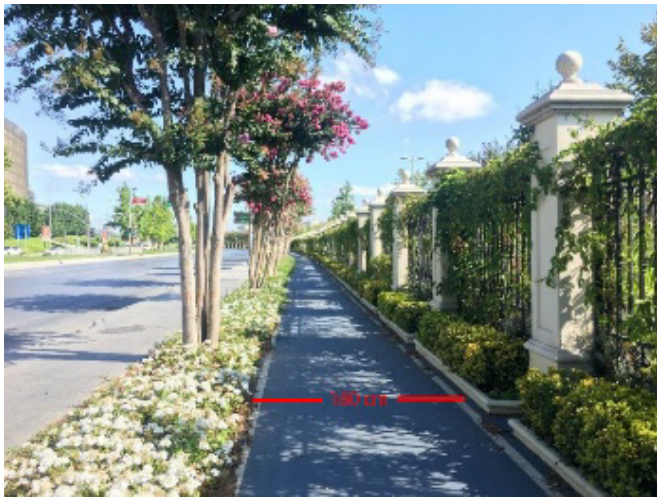
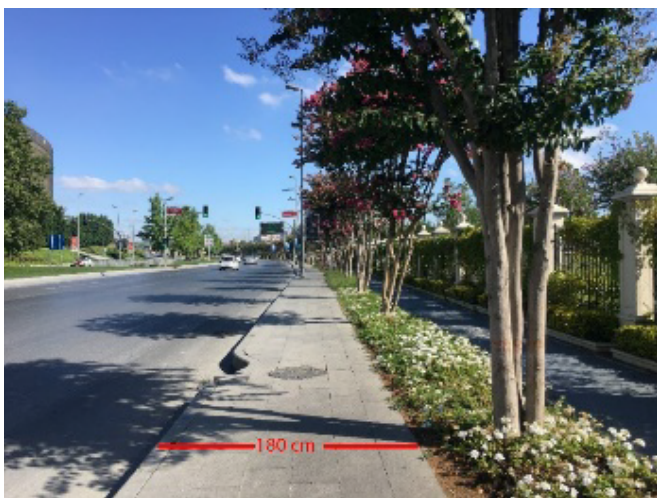
In Zone 2 of the gardens, the surrounding paving features pedestrian walking roads, bicycle paths and green areas, and serves three different functions. Each area has a width of 180cm. Because there is no difference in elevation on entering the gardens, wheelchair users can enter easily. The pavement has a cross slope of 1% and a longitudinal slope of 3%. The material covering the ground is suitable for physically disabled users. In Figure 47, the plants with branches

hanging over the pavement have kerbstone borders which are suitable and efficient. There is no protective kerb to prevent cars from parking on the edge of the pavement. The electricity poles, lighting and signage on the pavement are suitable. When evaluated according to the standards, the pavement is of a suitable size to be used by wheelchair users (Figure 46 and Figure 47).

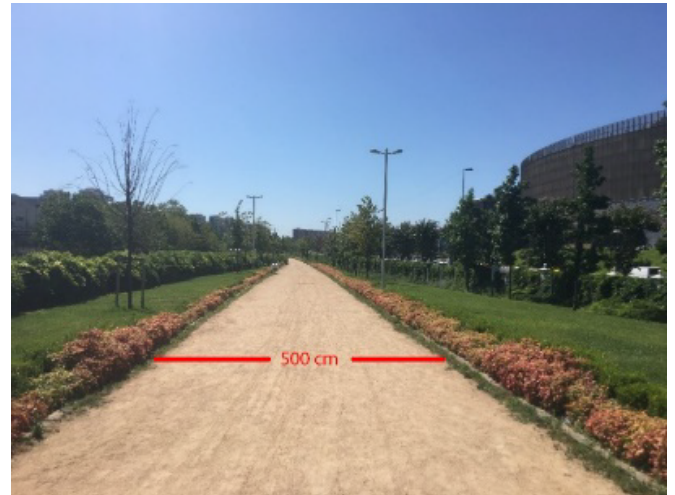
Figure 48. Zone 2, pedestrian road (Photo 5)

The pedestrian road shown in Figure 48 has a width of 500cm and is suitable for wheelchair passage in both directions. The pedestrian road has a slope of 2%. The drainage grate is perpendicular to the road and the grating spacings are 1.3mm. Because it is an earth road, it is affected by bad weather conditions and there is some unevenness. The protective kerb around the road is less than the standard 5cm. Because soil and sand materials have been used for the pedestrian road, this poses problems for disabled individuals walking and getting wheelchairs to move. For this reason, the

pedestrian road is unsuitable for wheelchair users.

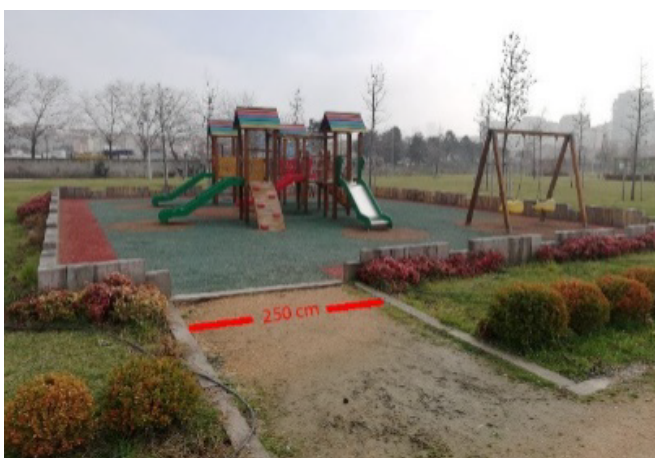
Figure 52. Zone 2, children's playground (Photo 7)

The children's play area shown in Figure 52 features a slide unit, a climbing frame and swing equipment. For the disabled to be able to use wheelchairs without assistance, there must be safety precautions taken for special play elements (swings, etc.) designed specifically for disabled users. The play elements are not suitable for use by wheelchair users.

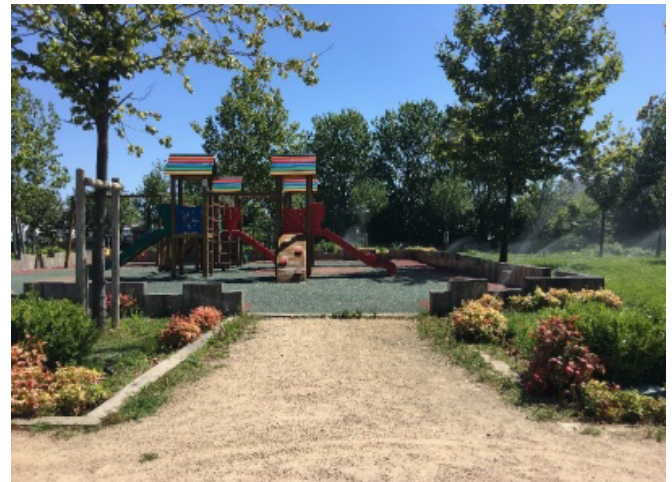
Figure 53. Zone 2, children's playground (Photo 9)

As Figure 53 shows, there are normal swings in the children's play areas of the gardens. Features like slides, seesaws and swings are found in every children's park. Play elements that can be used together by abled and disabled children are recommended. Because there is an elevation difference at the entrance to the area and a ramp has not been constructed, the area is unsuitable for wheelchair users.

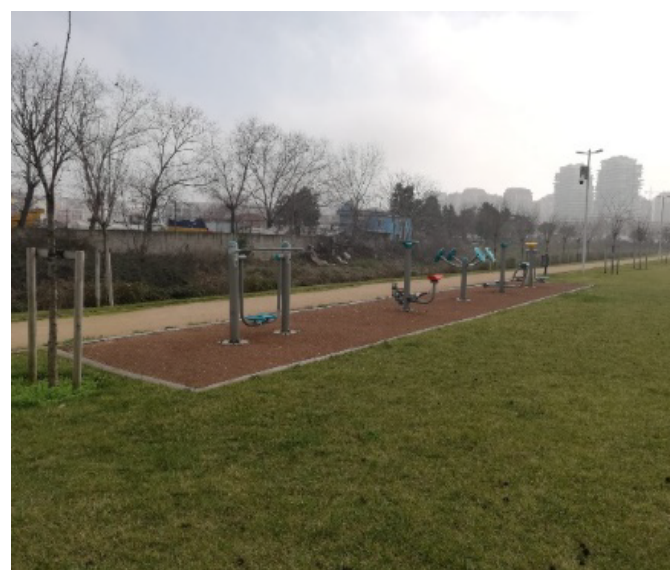
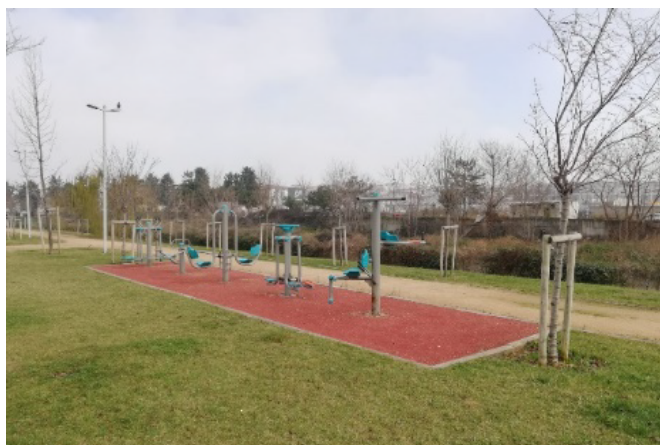
In Zone 2, there is exercise equipment in two areas. Most of the exercise equipment is designed for children using their feet, which is a problem for disabled users, and there is no equipment for exercising the hands and arms; the space between devices is 120cm. It was determined that the exercise areas in this zone are not suitable for wheelchair users.

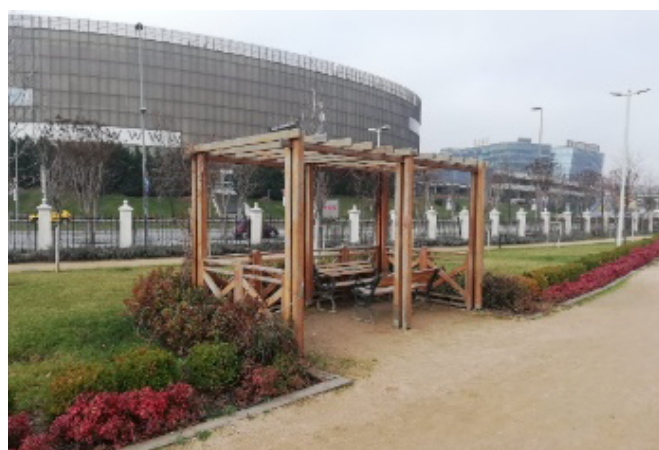
Figure 59. Zone 2, overhead cover elements and seating area (Photo 14)

The overhead covering elements shown in Figure 59 may be used as sun shades, but are inadequate for bad weather. Under these covering elements, the separately added seating elements have a 150 x 150cm space left on one side where wheelchair users can wait comfortably. In this zone, the overhead covering elements do not provide obstacles to mobility impaired users; however, the physical structure that should provide the expected function is inadequate.

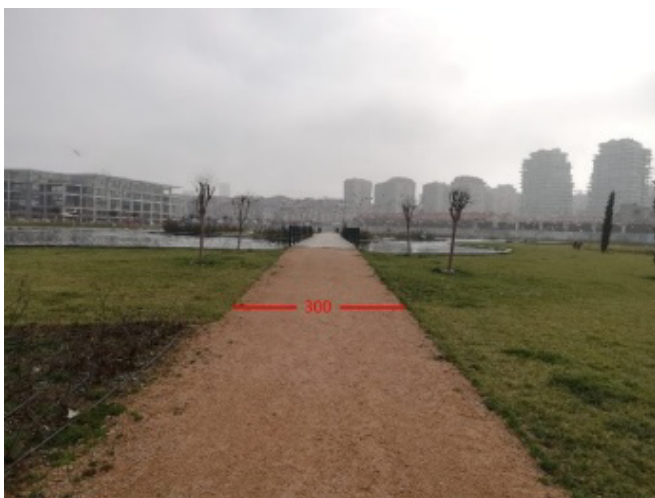
Figure 61. Zone 3, sloping pedestrian road (Photo 1)

The sloping pedestrian road shown in Figure 61 has a width of 300cm, and is suitable for two wheelchair users to pass one other. The ramp slope is 2%; and it is suitable for use by everyone. Between the planted area and the pedestrian walkway there is no separating element. Soil has been used as the ground surfacing material. While this may appear suitable from an aesthetic perspective, in the course of time, bumps and depressions will develop, creating potential danger for mobility impaired individuals.

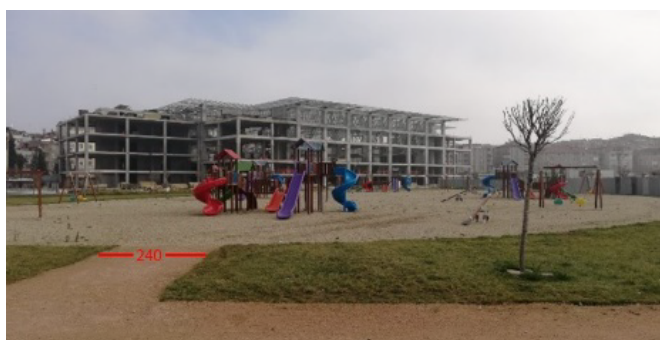
Figure 64. Zone 3, children's playground (Photo 4)

There is a children's play area in only one place in this region. As in the other zones, slides and swings are in use; but the children's play elements are only intended for use by abled children. Here there needs to be play equipment designed for everyone to be able to use and play with. For disabled users to use these kinds of play elements they would require help from outside, and if they were to use them on their own, they would be vulnerable, as there are no safety precautions in effect, and accidents can happen.

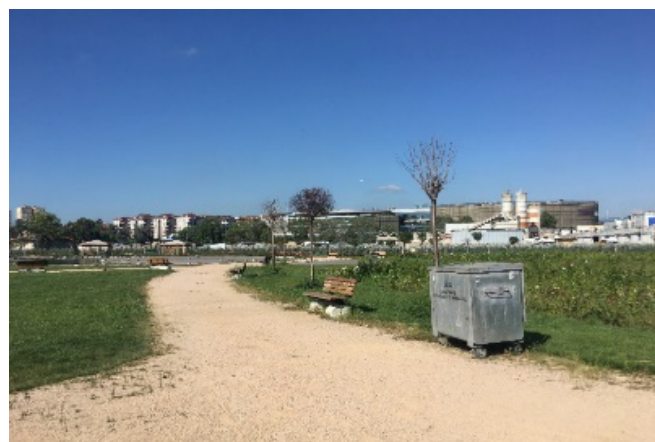
Figure 66. Zone 3, trash container (Photo 6)

The overhead protective elements used here were observed to provide suitable protection from poor weather conditions and the sun. They are easy to use and provide opportunities for rest to mobility impaired users (Figure 65). According to the standards, the height of openings of trash containers from the ground must be 90-120cm. As Figure 66 shows, in Zone 3 trash dumpsters are used in place of trash cans, and these are unsuitable according to disability standards. In terms of measurements, they are suitable for wheelchair users, but from the point of view of usage and ergonomics they are unsuitable.
