# Simulation-Based Investigation of Crack Formation in Forged MB15 Magnesium Alloy

**Abstract:** In the process of riveting an MB15 forging die, cracks were discovered emerging along the longitudinal direction and near the riveting hole. Through fracture analysis, microscopic observation, energy spectrum analysis, metallographic examination, and hardness test, the properties and causes of the cracks are discussed. The results indicate that the cracking type is intergranular brittle cracking, occurring during the forging stage. Furthermore, the recrystallization at the crack site is found to be incomplete, which is attributed to the low deformation temperature.

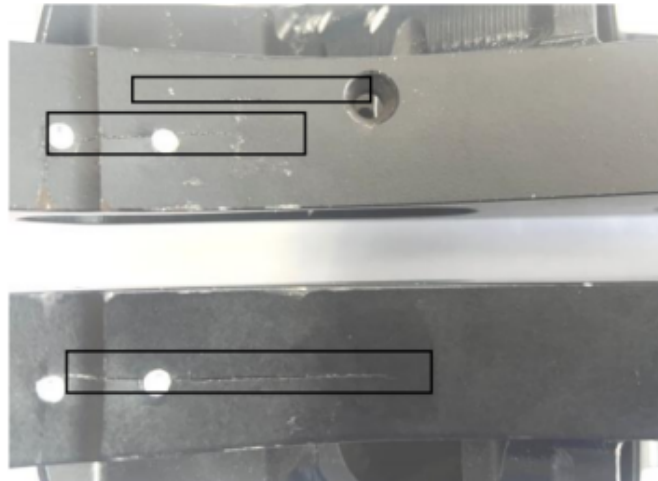
After undergoing chemical oxidation and paint treatment, the forging surface appears black. Cracks are distributed parallel to the forging flow line, with some penetrating the entire thickness from the outer wall, while others do not. These cracks exhibit a flat and straight nature, and local positions reveal the presence of multiple cracks, as depicted in **Figure 1**.

**Figure 1.** Macroscopic morphology of cracks

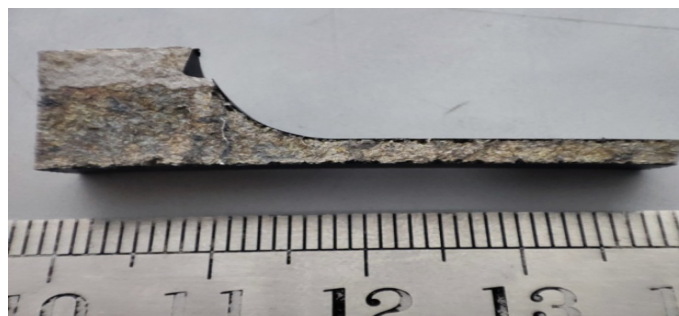
For macroscopic observation, the crack location was manually opened. Cracks extend from the outer wall towards the interior, resulting in relatively level fractures. The original crack area appears dark gray, and the local crack area exhibits a yellowish-brown tint with a noticeable small step characteristic. The artificially interrupted fracture appears silver-gray, as illustrated in **Figure 2**. The original cracked area and artificially interrupted area were observed respectively under stereomicroscope, and the step characteristics and reflective features were visible in the original cracked area, as shown in **Figure 2**. The fracture in the artificially interrupted area was fibrous, as shown in **Figure 2**.

**Figure 2.** Macroscopic morphology of the fracture

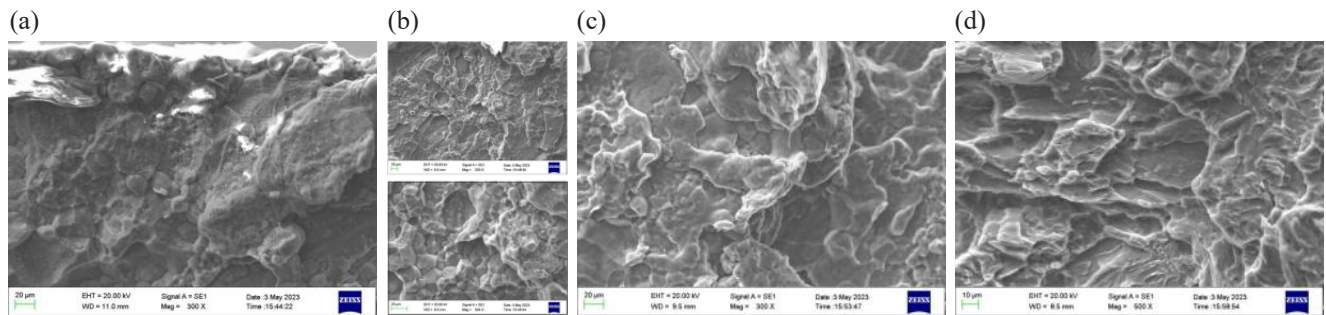
The crack fracture was examined under a scanning electron microscope (SEM). In the initial crack zone, the fractures appeared flush, covered with a substantial amount of oxides. Local, clear intergranular characteristics were observed, and no metallurgical defects were present, as illustrated in **Figure 3(a)**. During the middle stage of expansion, the fracture exhibited evenness, displaying layered cracking characteristics. Upon magnification,

the fracture was found to be intergranular, with noticeable oxide adhesion on the crystal surface, as depicted in **Figure 3(b)**. The characteristics of fractures at the end stage of the expansion were similar to the middle stage, showing intergranular with the crystal surface exhibiting oxidation, as shown in **Figure 3(c)**. Fractures resulting from artificial interruption displayed cleavage-like features, as depicted in **Figure 3(d)**.

**Figure 3.** Microscopic observation of the crack fracture. (a) Initial cracking zone; (b) Middle stage of expansion; (c) End stage of expansion; (d) Artificial interruption of the fracture

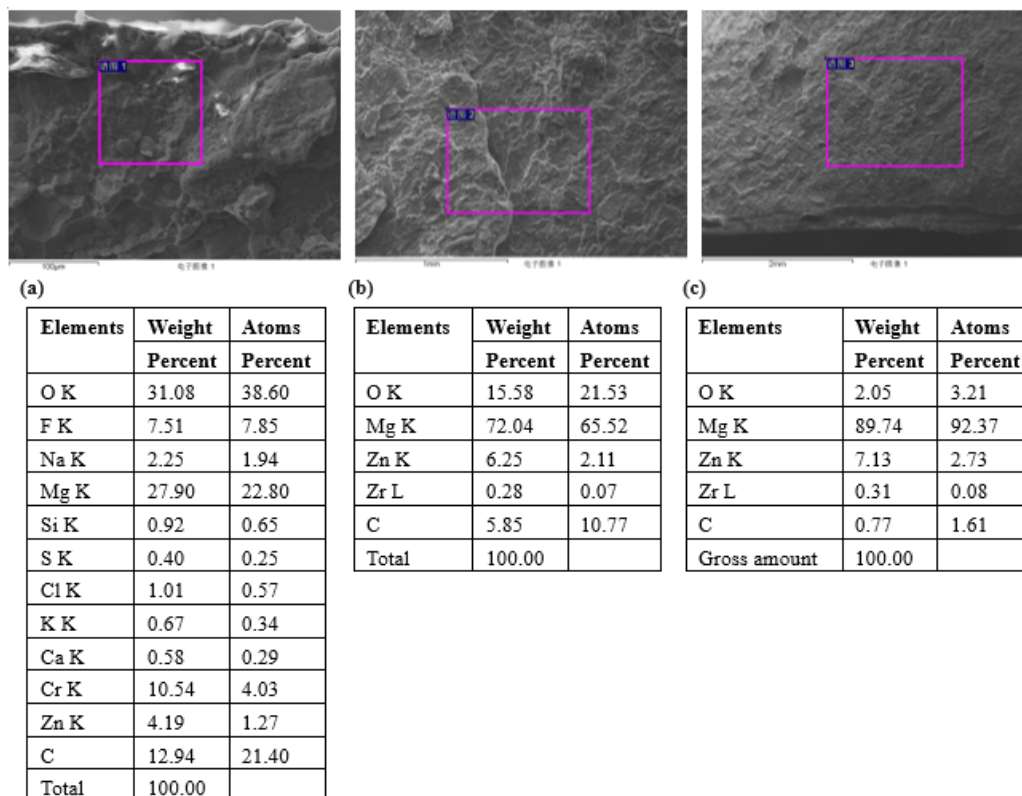
The crack's source region, expansion region, and artificially induced fracture region were analyzed separately. In the crack source region, additional elements such as O, F, Na, and Cr were identified. Elements such as F, Na, and Cr originated from chemical oxidation, with the surface crack fracturing during this process, as illustrated in **Figure 4(a)**. The expansion zone exhibited a higher concentration of O elements, while the types and contents of the main alloy elements essentially met the requirements of the MB15 alloy, as shown in **Figure 4(b)**. In the artificially induced fracture, the O element content was significantly reduced due to natural oxidation, yet the types and contents of the primary alloy elements met the specifications of the MB15 alloy, as depicted in **Figure 4(c)**.

**Figure 4.** Energy spectrum analysis of the crack. (a) Source area; (b) Expansion area; (c) Artificial interruption area

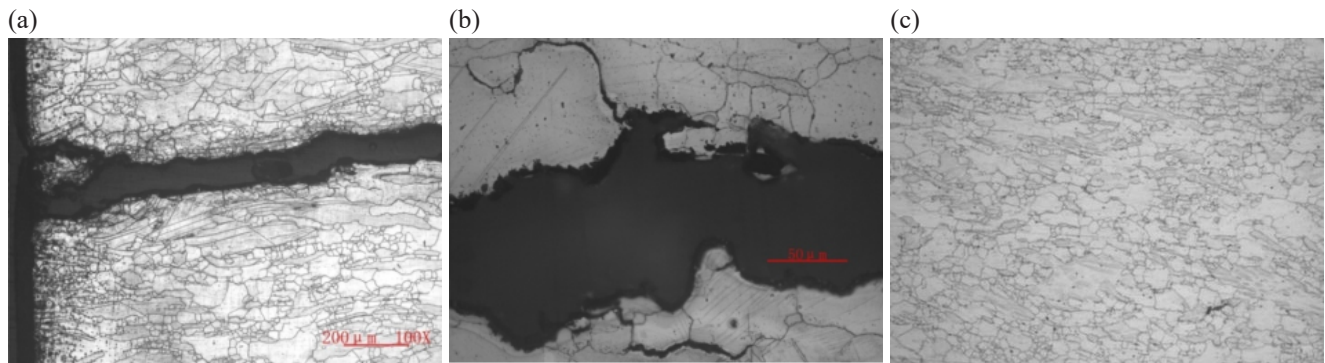
Metallographic structure detection was performed at both the crack location and the intact location. It was observed that the cracks primarily propagated along the crystals, demonstrating good alignment between the two sides of the cracks. Simultaneously, a substantial number of elongated deformed grains and deformation bands were evident, with occasional occurrences of equiaxed crystals in local areas, as illustrated in **Figure 5(a)**. During the expansion stage, secondary cracks appeared on both sides of the main crack, extending along the crystal structure, as depicted in **Figure 5(b)**. No signs of overheating or overburning were observed in the structure. The normal position's metallographic structure morphology is presented in **Figure 5(c)**.

**Figure 5.** Metallographic analysis. (a) Initial cracking zone; (b) Expansion area; (c) Metallographic structure at normal position

In summary, it is deduced that the forging cracking is intergranular and brittle. The structure near the crack consists of elongated deformed grains and a few fine equiaxed crystals, with a visible deformation zone, indicating a low degree of recrystallization. The main factors influencing recrystallization include the original material structure, deformation rate, and deformation temperature. The degree of recrystallization away from the crack is higher than at the crack location, suggesting that the main factors affecting recrystallization at the crack location may be a rapid deformation rate or low deformation temperature during forging. However, a rapid forging deformation rate may increase the number of crystal twinning, resulting in a higher hardness value

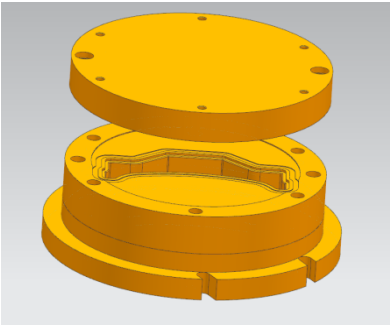
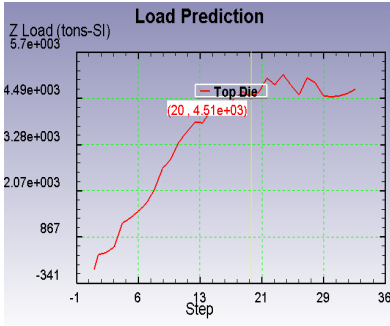
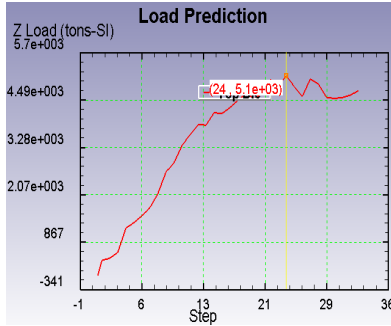
**Table 2.** Mold structure and forming tonnage diagram

A simulation analysis was conducted on the forging mold with the mold structure detailed in **Table 2**. During forging, the blank is positioned in the lower mold, and upon the initiation of the upper mold's downward movement, the blank takes shape, reaching the desired displacement. The simulation analysis employed finite element software, and the parameters are outlined in **Table 3**. The design requirements specify that the forging process must be devoid of defects such as incomplete filling and folding, with the forging tonnage not exceeding 6000 T (in line with the equipment capacity of 6000 T).

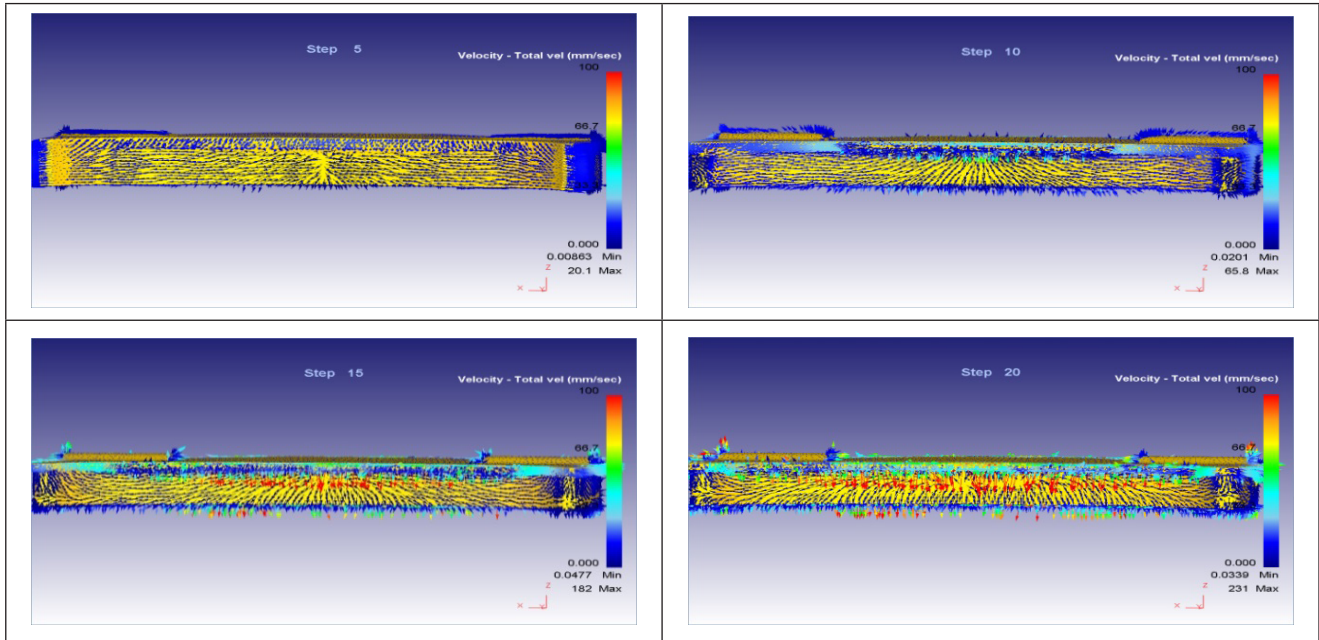
**Table 4.** Blank flow diagram

Upon physical inspection (refer to **Table 4**), it is evident that during secondary forging, the material flows to both sides, and the forging fibers follow a horizontal direction. The low temperature of the blank induces the initiation of forging cracks along the fiber direction, aligning with the results observed in the metallographic analysis.
