# Analysis of Damage Pattern of Road Bridge Landslide in Mountainous Area

**Abstract:** Through on-site defect investigation, special inspection, and finite element simulation calculation of a high-speed upper-span (30 + 32 + 30) m prestressed concrete box girder bridge, the overall sliding force of the bridge on the right side of platform 0# is analyzed. In this situation, typical defects such as overall girder slippage, support dislocation, pier column deviation, and pier bottom side cracks have occurred in the overpass. At the same time, combined with simulation calculation analysis, it is interpreted that the 0# and 1# foundation has been damaged at a certain position below the ground line. The occurrence of broken piles has provided a reliable basis for the later reinforcement and maintenance of the bridge and ideas for emergency inspection and analysis of bridges damaged by the same type of landslides.

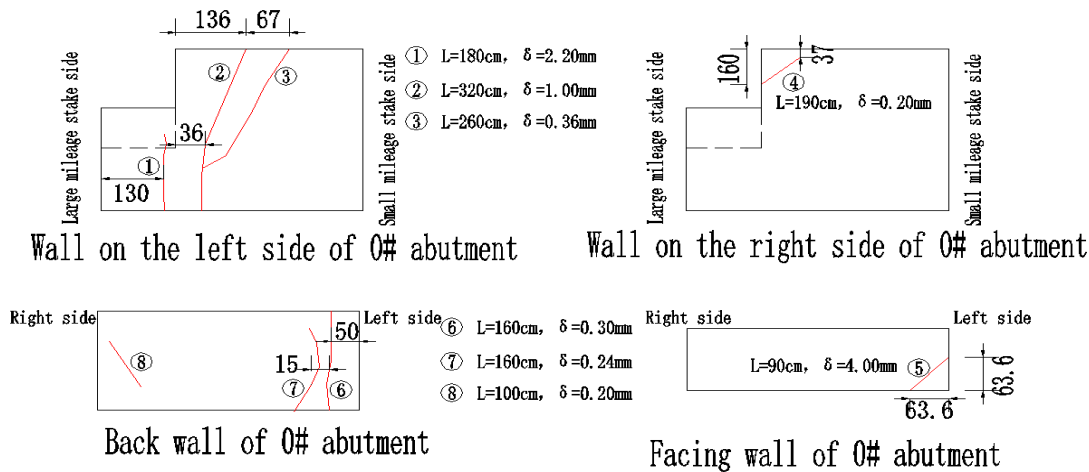
Both the 0# platform and the 3# platform are in contact with the main beam, the concrete of the 0# platform is partially squeezed and damaged, and the back wall of the 3# platform has a horizontal crack; a total of 8 oblique cracks were found on the 0# platform (side wall, back wall, pile protection wall), with a length ranging from 90 cm to 360 cm and a width ranging from 0.20 mm to 4.00 mm; 6 horizontal through cracks were found on the longitudinal small pile surface at the bottom of the 2# pier, within a range of 0.3 m to 1.8 m from the bottom of the cap, with a spacing of 20~30 cm, length 350~466 cm, and crack width range 0.18~0.24 mm. The crack distribution diagrams are shown in **Figures 3 and 4**.

Figure 3. Distribution map of vertical and oblique fractures in platform 0# (L is fracture yield, delta is fracture width)

- (3) Oblique cracks in the 0# platform body: Due to the displacement of the soil slope on the top of the 0# platform, the 0# platform received excessive earth pressure, and the concrete tensile stress of the platform body exceeded the concrete tensile stress, causing cracking.

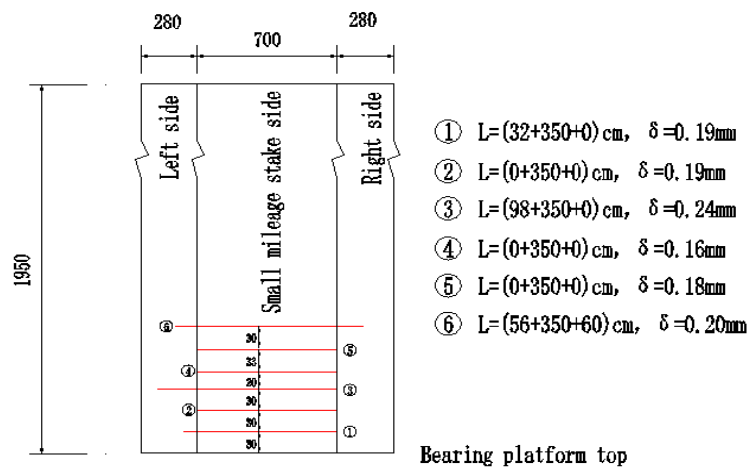
Figure 4. Distribution of horizontal cracks on the side of the bottom of 2# pier (L is the fracture rate, delta is the crack width)

- (4) Horizontal cracks on the side of the small pile number at the bottom of the 2# pier: the main beam displaces to the side of the large pile number. Since the 2# pier is a consolidated support, the main beam drives the pier column to cause deformation, and, ultimately, the tensile stress at the bottom of the pier exceeds the limit.

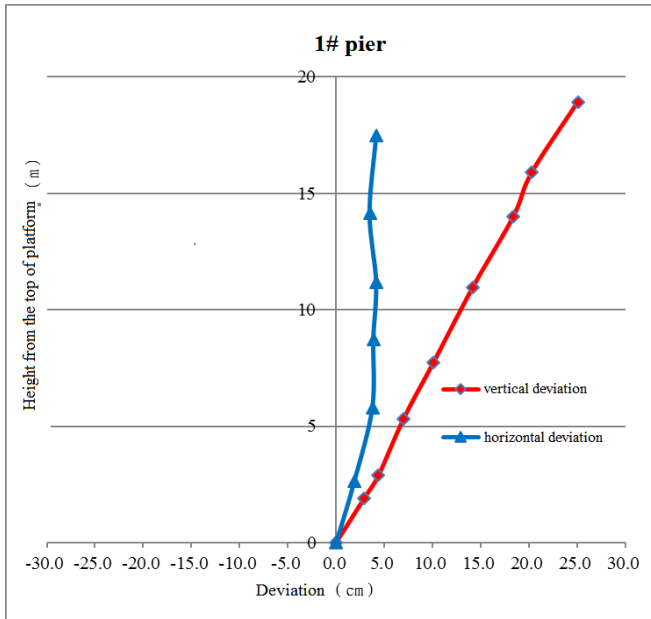
It can be seen from the verticality measurement results in the table below: (1) 1# pier is displaced 25.1 cm longitudinally to the large pile number, and 4.2 cm laterally to the right; (2) The 2# pier is displaced longitudinally by 5.5 cm to the large pile number, and laterally by 0.6 cm to the left.

**Figure 5.** Measurement results of verticality of 1# pier body

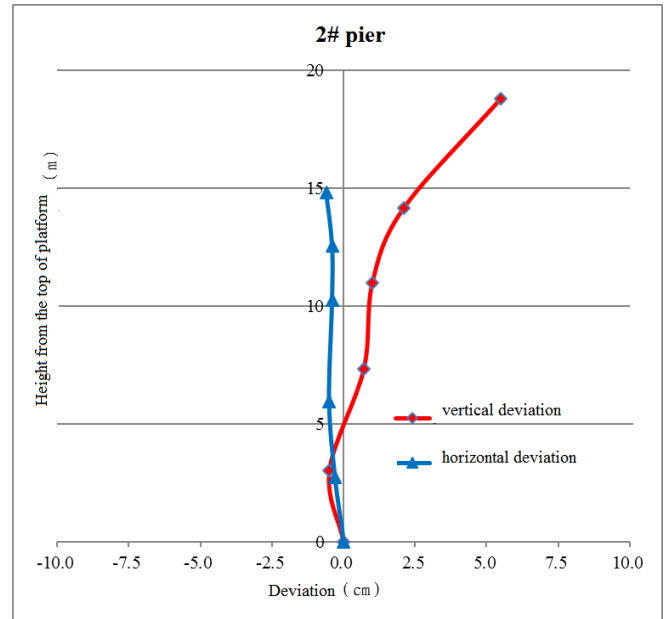
**Figure 6.** Measurement results of verticality of 2# pier body

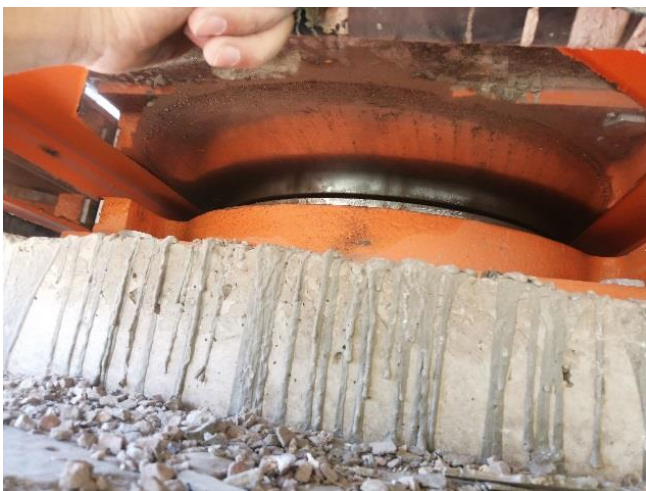
It can be seen from the test results that the vertical displacement of the 0# platform support to the large pile number is 4.0~7.5 cm, while the longitudinal relative displacement of the 1# pier support to the large pile number is 21.5~22. The displacement is 3.5 cm, and **Figures 7–10** show the typical diseases on site.

**Figure 7.** Longitudinal large pile number displacement of 1-1# support

- (1) Offset of 0# platform and 1# pier: the overall slip of the slope at 0# platform causes the displacement of the pier abutment. Due to the inconsistent displacement of the main beam and pier column, it also causes the movable support to be adjusted up and down to level the steel plate. There is a offset between them.

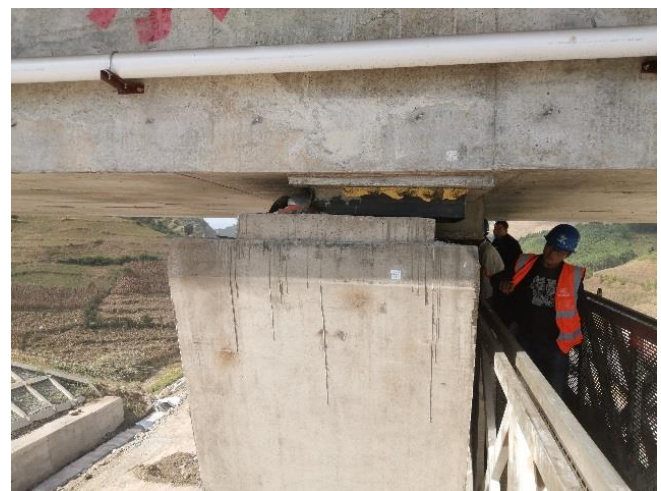
**Figure 8.** Longitudinal large pile number displacement of 1-1# support

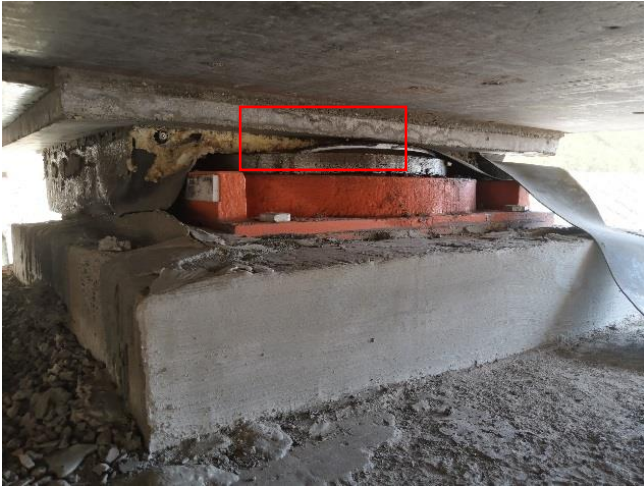
**Figure 9.** PTFE slide plate warping of 1-1# support

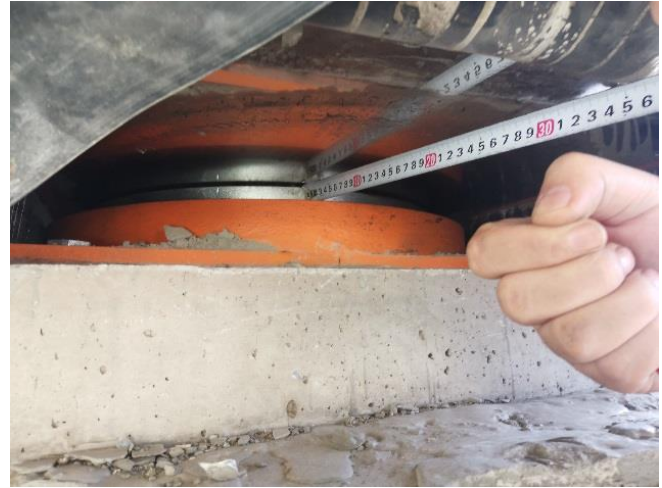
**Figure 10.** Longitudinal large pile number displacement of 1-2# support
