# Investigating the Problems and Proposing Solutions for Rural Residential Buildings in Northwest China

Zhaobo Zhang<sup>1\*</sup>, Jianqiang Wang<sup>2</sup>, Mao Hu<sup>3</sup>

<sup>1</sup>Department of Civil Engineering, Gansu Agricultural University, Lanzhou 730070, Gansu Province, China

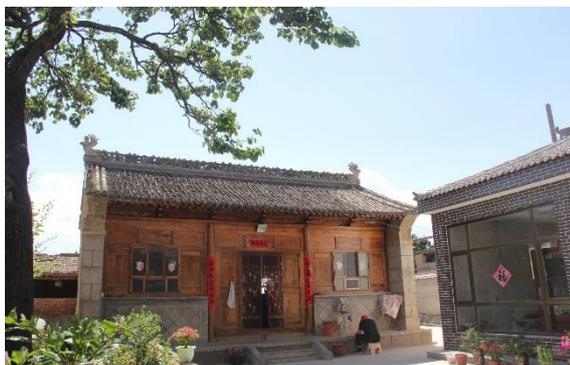
From the perspective of architectural style and feature, the construction materials of RRB built in the past 10 years were mainly reinforced concrete and masonry, resulting in monotonic architectural styles and a high degree of similarity. However, preserved architectural styles that represent regional cultural characteristics (**Figure 3** and **Figure 4**) face the risk of being lost. The reason is that in the mind of the majority of owners, the RRB constructed with soil and wood, which have been used for several generations, no longer conform to the characteristics of the current era. With the increasing income of owners, the unwillingness to use outdated soil and wood as construction materials is more prevalent; instead, they are more willing to use stronger and modern brick-concrete and cast-in-place reinforced concrete structures.

**Figure 3.** RRB with cultural characteristics

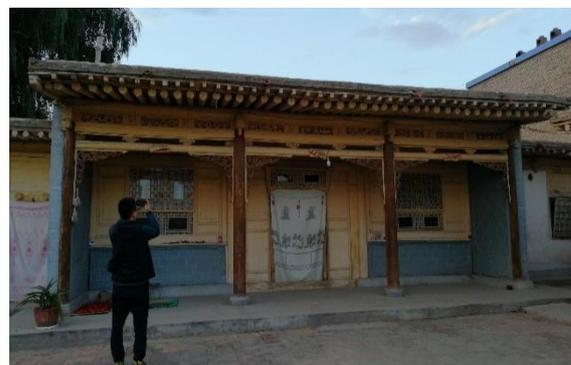
**Figure 4.** RRB with cultural characteristics
