Renovation and Protection Project of Peking Union Medical College: Renovation and Reconstruction Design of Concealed Works

Abstract: Peking Union Medical College (PUMC), as the representative work of Chinese modern architecture, has had a great impact on the development of Chinese modern architecture. Its advanced and complete concealed works contain great value and are valuable materials for the study of Chinese modern architecture. This paper studies the concealed works of PUMC, enriches the research data in this field, and summarizes the transformation design scheme of concealed works in the protection and repair of ancient buildings of PUMC.

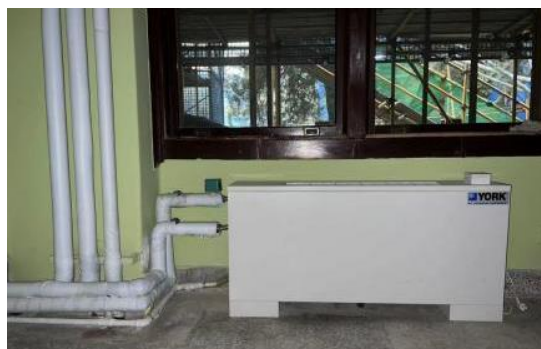
Figure 5. Fan coil

In order to reduce the damage to the overall appearance of the historic building, fan coil air conditioning is used, the original air conditioning and outdoor units are all removed, and the air ducts, water pipes, air outlets and air conditioning ends are concealed. At present, there are no specific requirements regarding air conditioning, so we will maintain the original plan and optimize the design on this basis. The installation method of fan coil is shown in **Figure 5**.

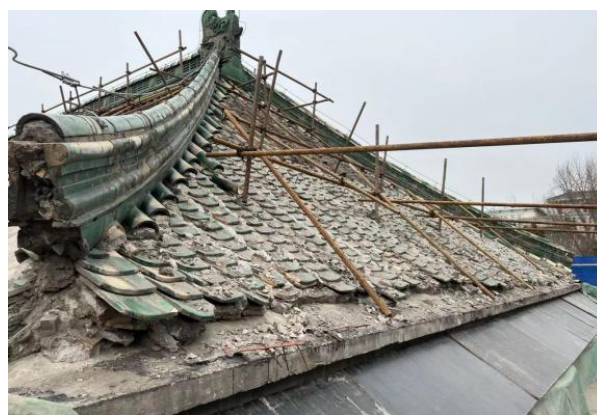
Figure 7. Roof waterproofing treatment

- (1) The project adopts combined sewage and wastewater flow system, and the sewage and wastewater above +0.000 indoors is discharged into the outdoor sewage network by gravity.
- (2) The roof adopts the gravity flow outward discharge mode, which is collected and discharged to the outdoor sewage pipe network. In this project, the waterproof characteristics of the roof will be restored and the tile surface will be partially repaired and replaced to ensure that the overall style will not be changed.

Construction status of roof waterproofing treatment is shown in **Figure 7**.

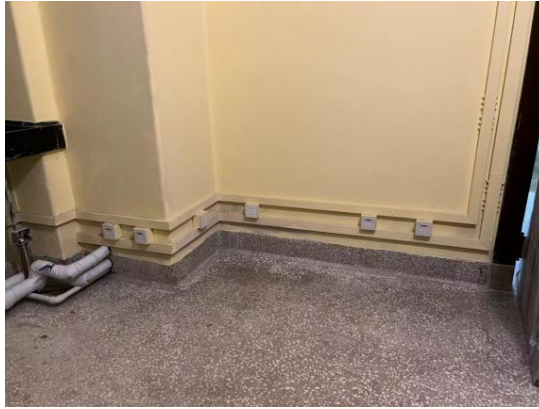
Figure 8. Surface mounted electrical circuit

The original electrical system pipelines in the buildings of this project are basically laid in the walls, and the pipelines are aging and seriously damaged. In addition, the lines are chaotic and difficult to sort out, so the original lines can no longer be used. Therefore, the electrical pipelines will be rearranged in this project. To ensure that the building interior decoration is coherent with the historical style, the project has designed a connecting frame in the corridor. All lines are connected to each room through the connecting frame above the corridor. The lines in the rooms are painted with colors that are consistent with the wall, so as not to affect the overall style of the building.

There are two reasons for choosing open installation indoors. Nowadays, the number of electrical engineering lines in the building has greatly increased compared with a hundred years ago, and the original trunking space in the building wall cannot meet the current demands, so the new lines can only be installed and laid in the open. (2) The walls involved are made out of hollow bricks, these hollow bricks has a hundred years of history belongs to the category of cultural relics. If the lines were to be grooved into the walls, it will be better for the overall appearance, but it will inevitably be a great destruction of cultural relics. Hence, in order to protect the cultural relics, open installation is chosen as the method of electrical wiring. The circuit installation mode can be seen in **Figure 8**.
