# The Research on the Evaluation and Optimization of the Traditional Dwelling Conservation Practice: A Case Study of Cheng Zhi Hall Restoration Project within Hongcun

**Abstract:** Hongcun is the World Cultural Heritage which is a Traditional Village in China, and Cheng Zhi Hall is the most important traditional dwelling within Hongcun. In December 2010, Yi County Cultural Relics Bureau commissioned Anhui Provincial Cultural Relics Protection Center to complete the Restoration Plan of Cheng Zhi Hall, Hongcun Village, Yi County, Huangshan City, Anhui Province, and carried out the actual restoration project from 2015 to 2018. However, by the evaluation of the restoration plan and project of Cheng Zhi Hall, many problems are found such as that the description of restoration measures is rough, the restoration drawings are not clearly marked, and the restoration practices are lack of the theoretical support and so on. Therefore, the aim of this research is to sort out the existing problems, and through the comparative study of the relevant Italian cases, putting forward the optimization strategies of the plan and practice of traditional dwelling conservation practice in China.

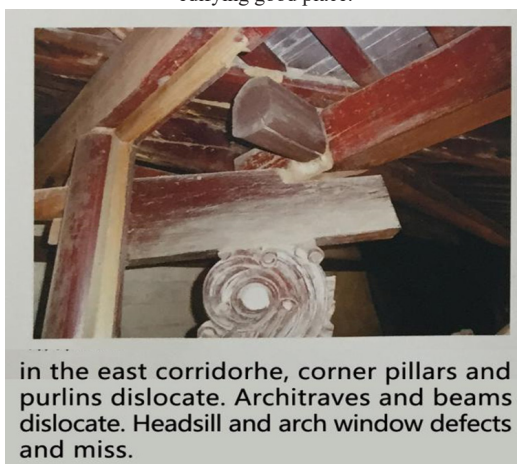
In the Chapter 2, the restoration plan provides substantial photos in total for 241 photos of the current situation of Cheng Zhi Hall. Not only including the wooden carvings, brick carvings, ceiling painting and other photos, more important contents are to provide the photos of decays of Cheng Zhi Hall, from the exterior wall, palanquin hall, front hall, back hall, study room, Tun Yun Xuan, Pai Shan Cabinet<sup>1</sup>, butler room, servant girl room and kitchen space, to present the photos of decays of various architectural components in these space as well as the short description (see Figure 2).

**Figure 2.** Photos of decays of Cheng Zhi Hall.

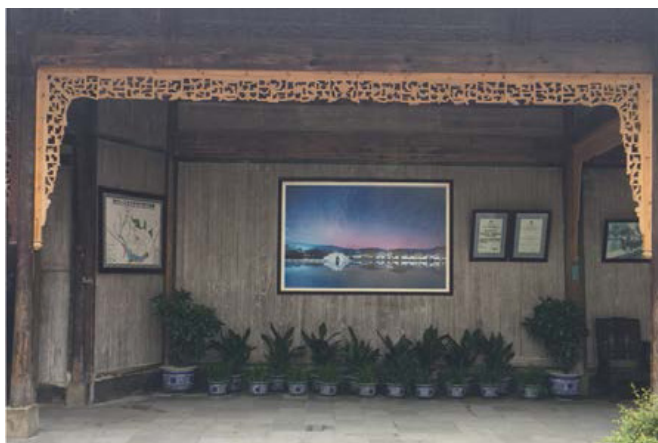
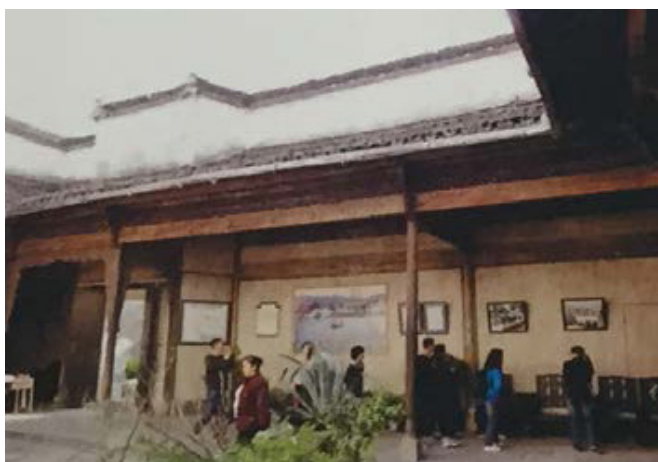
restoration principles and the limitations in technical cognition, the results of restoration project are not very satisfied and many restoration results are debatable. Especially in some practices of some wooden components, the restoration project replaces the new components directly, destroying the original architectural features of Cheng Zhi Hall.

For example, the Front Fei Zhao<sup>2</sup> of palanquin hall has been missing and is replaced with the newly made Front Fei Zhao. But also, the material is not under the strict selection which does not have the good compatibility with the original wooden components. Due to the newly front Fei Zhao of palanquin hall is the main architectural component of the Cheng Zhi Hall, causing the destruction of the architectural feature of Cheng Zhi Hall architectural style (see Figure 3).

**Figure 3.** The actual intervention of Front Fei Zhao (Above before restoration and below after restoration). ©Taking by author
