# Weathering Characterization and Degradation Analysis of Landscape Wooden Buildings in Semi-Arid and Sandy Area

**Table 1.** Types of weathering characterization

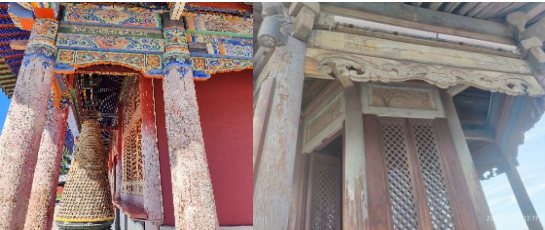
<p>Color changes: Surface fading, discoloration, dust, watermarks stains, and other phenomena. It mainly occurs on the surface of the outer component, forming a color difference with other parts.</p>

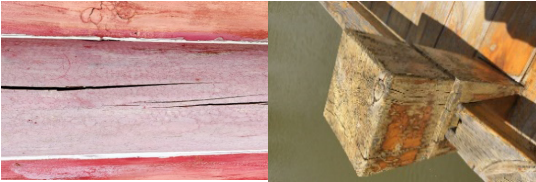
<p>Linear cracking: Splitting, cracking, and other phenomena. The main formation site is in the surface and the part of the component, along the direction of the wood fiber, forming cracks and radial diffusion along the wood ray.</p>

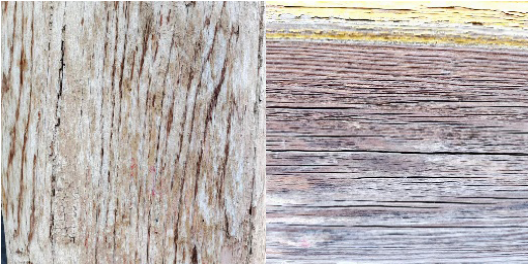
<p>Wind erosion: Wind erosion is generally accompanied by cracks (not forming through cracks) on wood substrates or unpainted wood surfaces, resulting in changes in surface roughness, as well as noticeable bumps, erosion, and other textures.</p>

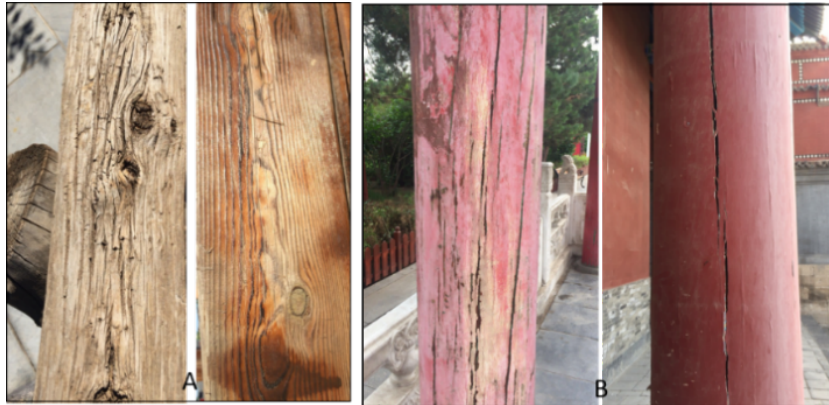
**Figure 2.** Examples of surface changes caused by sunlight

With sunlight as the trigger, indoor/outdoor or sunny/shady could produce different characterization differences as shown in **Figure 2**. Ultraviolet light is the main driving force for photodegradation of

wood surfaces. Wood absorbs light energy at many different wavelengths, and the photodegradation of wood occurs after the absorption of light energy. Trees are divided into early- and late-season timber within the annual rings. The early-season timber, which is looser, would be more susceptible to photodegradation, which was reflected in the appearance of a larger concave-convex wave pattern (**Figure 2-A**). On the other hand, because sunlight promotes the coating paint aging, it would form coating aging, with volatile loss and stress formation. Degradation is intensified by coating, resulting in loss of luster, color change, interface penetration and surface cracking, and other phenomena (**Figure 2-B**).

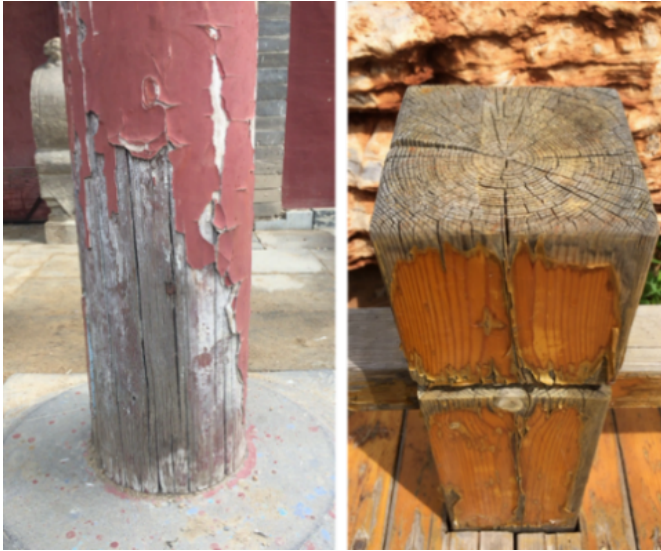
**Figure 3.** Examples of surface changes caused by moisture

The moisture content of wood was the main factor. In the process of wood weathering, precipitation promotes the loss of photochemical decomposition produced by leaching, resulting in the erosion of the wood surface; repeated changes in daytime temperature differences and relative humidity of the environment would contribute to the cracking of the wood surface, which allowed daylight and moisture to penetrate deeper into the inner layers, thus accelerating weathering. As shown in **Figure 3**, because the water absorption (moisture) of the cross-section of the wood should be larger than that of the radial and chordal sections, the degree of wetting and drying increases, and repeated wetting and drying also aggravates the degree of weathering, resulting in the cracked parts of the wood columns being concentrated in the ports and expanded along the fiber direction.

The higher the temperature, the faster the light deterioration and oxidation, but sustained high/low temperatures on the deterioration of wood was not as obvious as the above factors. Rather, the difference in temperature between day and night coupled with the role of humidity would cause weathering of the wood surface coating (**Figure 3**, **Figure 4-2**).
