Numerical Simulation and Reinforcing Technology Research on Collapse of Weak Interlayer Shaft

Abstract: The three-level shaft of the mixed pit shaft of Yixin Mine, built in 1983, failed continuously due to the influence of geological structure and the effect of water, which formed a collapsed space with a length of 18m, a depth of 12m, and a height of 12m at the level of -255m and to the southwest end. The 54m pit shaft below the -258m elevation of the pit shaft was filled with collapsed rocks forming a large loose body. The comprehensive processing plan for falling grouting and anchoring was proposed according to the geological conditions of the vertical shaft of the mixed pit shaft, adopting three-dimensional numerical simulation software as well as calculating the mechanical state of the vertical pit shaft surrounding rocks and using 3 to 5 parameters of Williams-Warnke failure criterion.

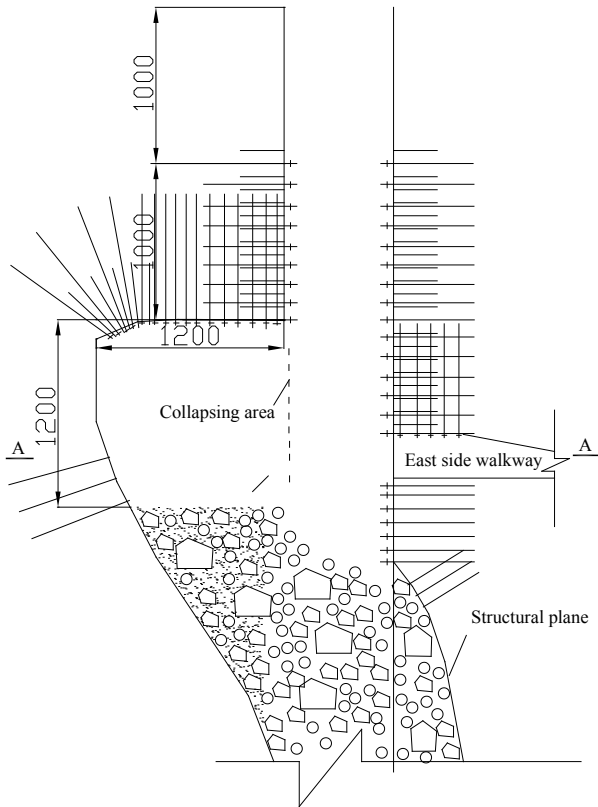
(1) At the -255m elevation of the third level, there is a goaf area of 18m \times 12m \times 12m to the southwest end of the pit shaft caused by the collapse of surrounding

(2) The 54m-shaft below -258m elevation of the pit shaft was filled with collapsed rock.

(3) A deep slump loose body was formed below the collapse area. No bedrock was found within 14m with the pit shaft detection.

(4) Cracks appeared on the arch of the 13-m wall of the pedestrian path on the east side of third level.

(5) Oblique cracks occur on the shaft wall which is 12m above the collapsed area.

Figure 1. Sketch map of the collapsed pit shaft

The Yixin Mine mixed pit shaft was built in 1983. Its ground elevation is +292m, the three-level elevation is -252.8m, the bottom elevation is -311.8m, the depth of the pit shaft is 603.8m, and its net diameter is $\Phi 7$ m. The area under -50m of the second level was drownd at some point. Due to the influence of weak rock masses and the force of water^[1], three-level structure of the pit shaft continued to drop in June of one year, which finally led to a massive collapse of the pit shaft (Figure 1).

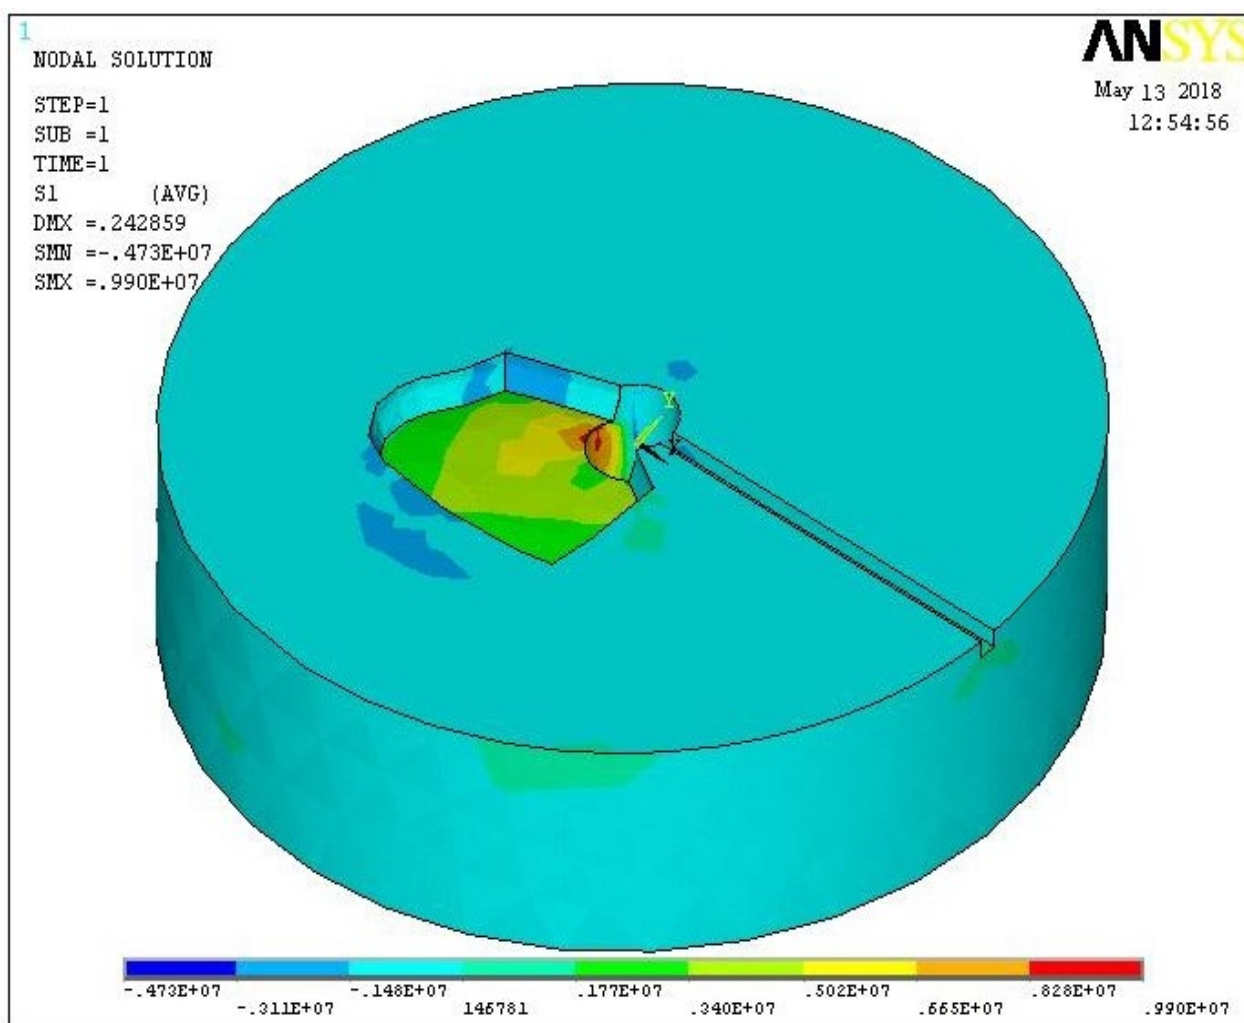
(1) Above the collapsed goaf area, the maximum principal stress s_1 of the shaft wall and surrounding rocks mass is mainly concentrated at the interface between the goaf area roof of collapse and the shaft wall, where the rock mass stress is mainly formed by the tangential stress concentrated above the shaft wall at the shaft collapse site and the stress concentration around the roof of the collapsed goaf area. The calculation results show that the maximum principal

stress s_1 of the rock mass in the plane of the collapsed goaf area roof is -56.85 MPa (the specified compressive stress is negative, the tensile stress is positive, the same below), which is 3.9 times more than the self-stress of the deep rock mass s_2 . There is a large range of tensile stresses in the rock mass at the edge of the collapse area (Figure 2 and Figure 3). The maximum tensile stress is 5.3 MPa. The main direction of the surrounding rocks movement is towards the collapse area, with a maximum displacement of 12.7 mm. After the pit shaft collapses, there is still a plastic zone in the rock mass of the partially sustained pit shaft which has a range of about 2m.

Figure 2. The map of 3D's distribution that the maximum principal stress for Pit shaft & collapsing area

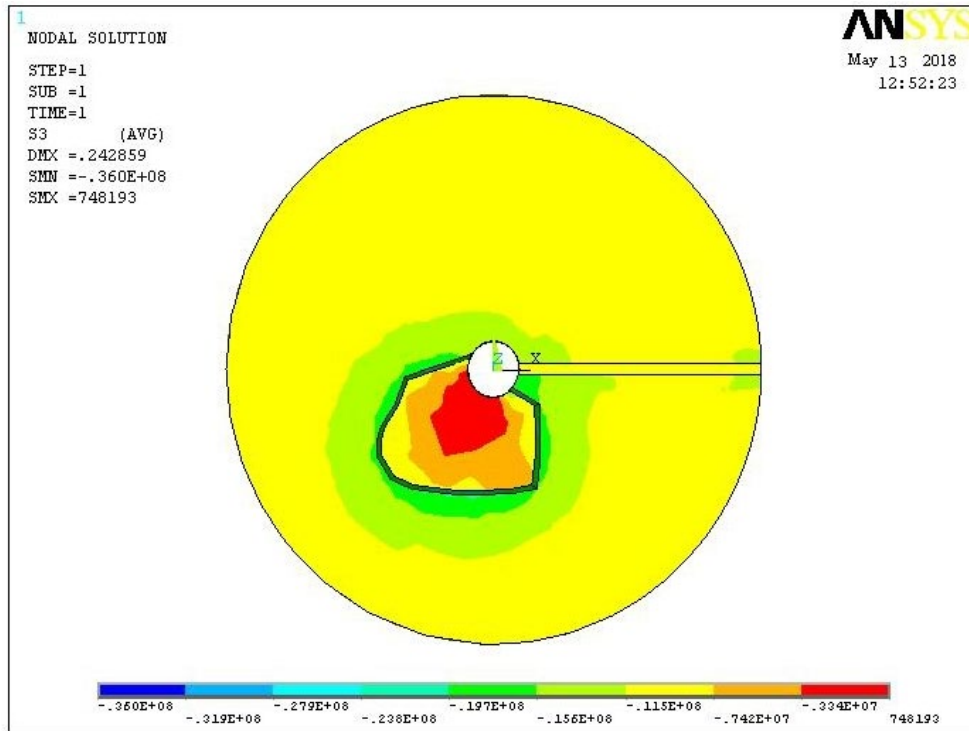
Figure 3. The transverse section map of the maximum principal stress which in the collapsed pit shaft location

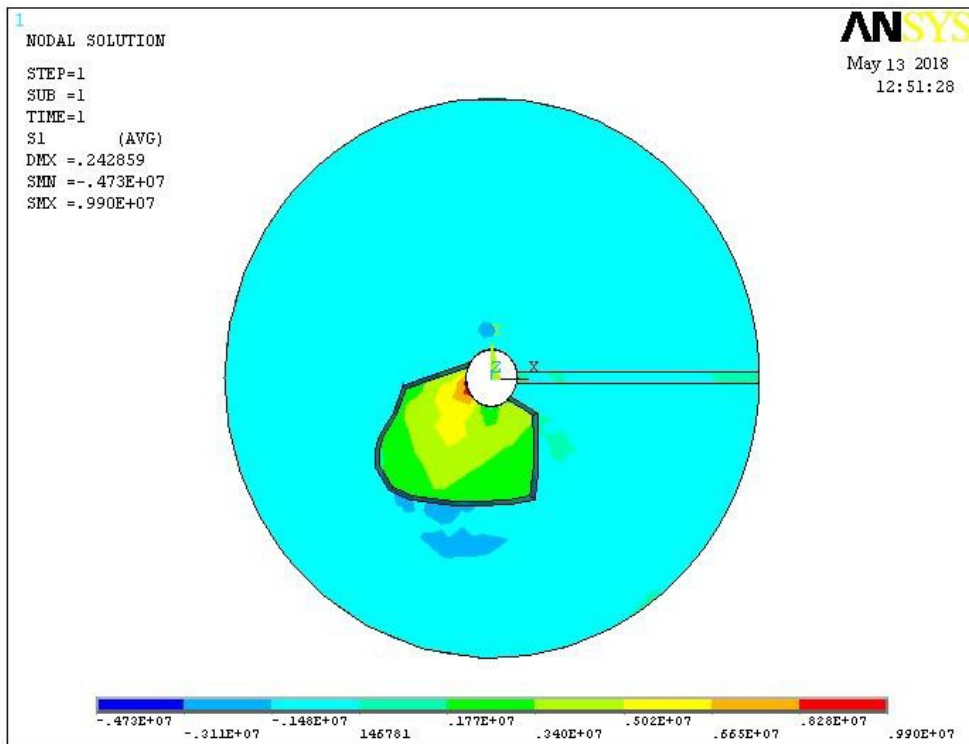
(2) The stress state of the rock below the collapsed goaf area is basically unaffected by the collapsed body, and the stress distribution of the surrounding rocks mass is mainly determined by the collapsed shape of the pit shaft (Figure 4). The maximum principal stress s_1 at the corner

of the collapsed shaft wall is 64.71 MPa. The tensile stress value in the rock mass at the shaft wall edge is reduced at a maximum of 0.79MPa. The shaft wall rock still moves in the direction of the collapsed pit shaft space with a maximum displacement of 10.7mm.

Figure 4. The transverse section map of the maximum principal stress which in the pit shaft & under the collapsing area

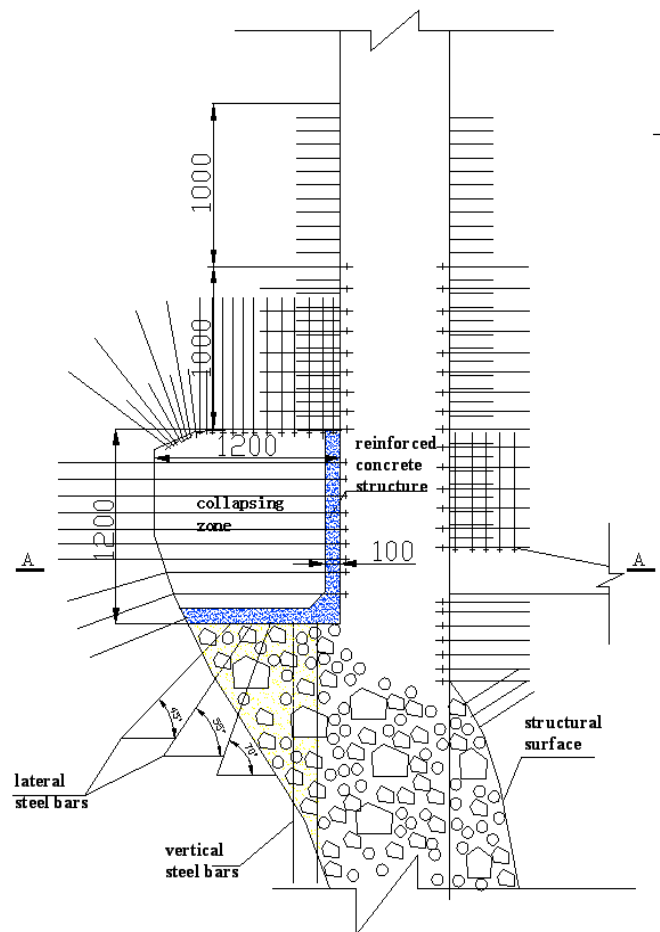
Figure 5. The transverse section map of the maximum principal stress which in the pit shaft & under the collapsing area

The specific reinforcement scheme is as follows (Figure 5-7):

(1) Arrange 5 rows of anchor holes in the collapsed body from outside to inside (relative to the center of the pit shaft), where the outer 3 rows are lateral, the hole depth is 12m (according to the results of numerical simulation, beyond the slip line 3m), and the inner 2 rows are vertical hole, with a depth of 11m. Implement two-fluid grouting, insert ribs afterwards which should use two rebars with a diameter $\phi 25\text{mm}$ and welded together.

(2) At the closed part of the reinforced concrete structure in the collapse area, the reinforced concrete is 100cm thick, the new shaft and the baseplate are chamfered at 45° with built-in steel bars to prevent the shearing and pulling failure of the joints under the surrounding rocks stress. According to the results of numerical calculations, the plastic zone in the rock mass of the non-collapsed pit shaft is only about 2m and the anchoring segment of the original design anchoring cable is still in the stable surrounding rocks. Therefore, the anchoring anchor in the original design can be extracted and locked on the inner wall of the pit shaft after the concrete curing period.

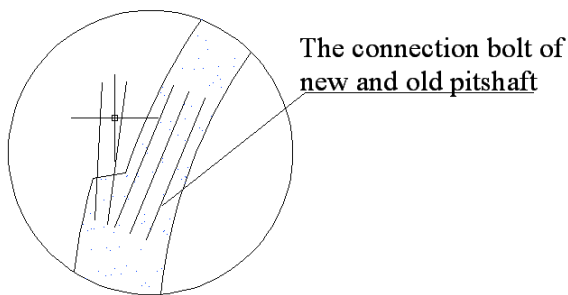
Figure 7. B dot's map of enlargement

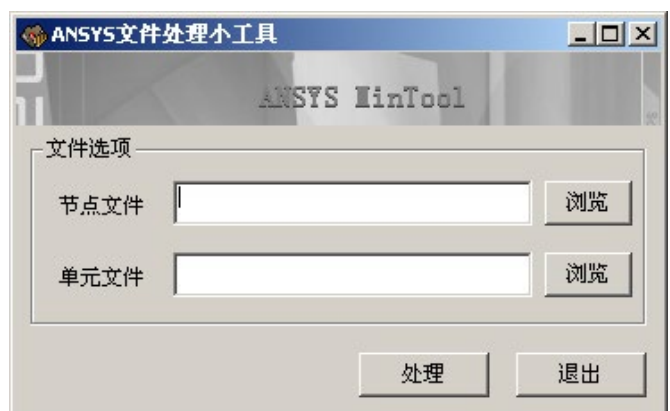
Figure 9. ANSYS file-neutral file conversion tool

(3) On the basis of numerical simulation, a comprehensive processing plan with collapsed body grouting and anchoring was adopted to reinforce the design and construction, something that has been proved by long-term monitoring as a reliable reinforcement scheme. (Figure 8-10)

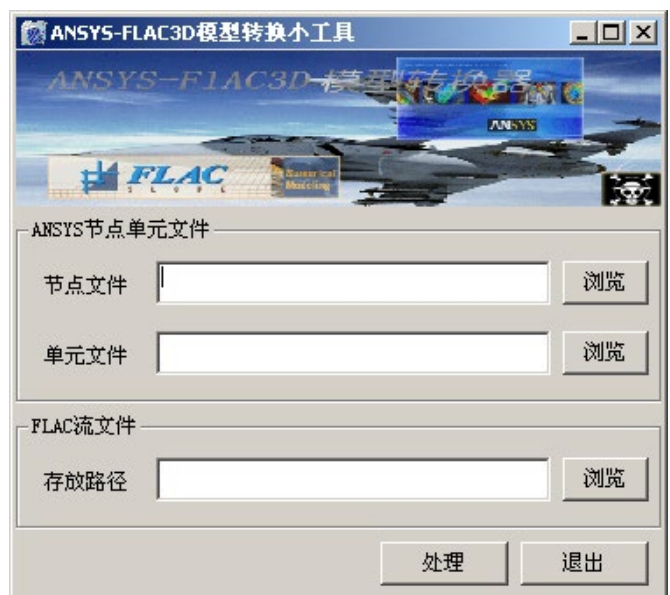
Figure 10. ANSYS-FLAC3D file conversion tool
