# Analysis of Reinforcement Techniques for Newly Built Tunnel Defects

To objectively understand the strategies for reinforcing and treating defects in newly built tunnels, this article takes the Jinfeng Tunnel in Chongqing, which was officially opened to the public in 2024, as an example. The Jinfeng Tunnel starts at Daishan Avenue in Bishan District and ends at Gaoxin Avenue in the High-tech Zone, with a total length of 9.20 km. It includes four casing interchanges, one tunnel, and comprehensive pipeline network ancillary projects. In 2018, the feasibility study report for the Jinfeng Tunnel was approved by the National Development and Reform Commission, and construction officially began on December 29, 2019. In September 2022, the Jinfeng Tunnel entered the construction scope of the ramp for the beltway. In May 2023, the main structure of the tunnel was completed, and in April 2024, the Jinfeng Tunnel was officially opened to the public. The designed speed of the Jinfeng Tunnel is 60 km/h, with a two-way six-lane design, and the total project investment is 5,170,368,500 yuan <sup>[2]</sup>.

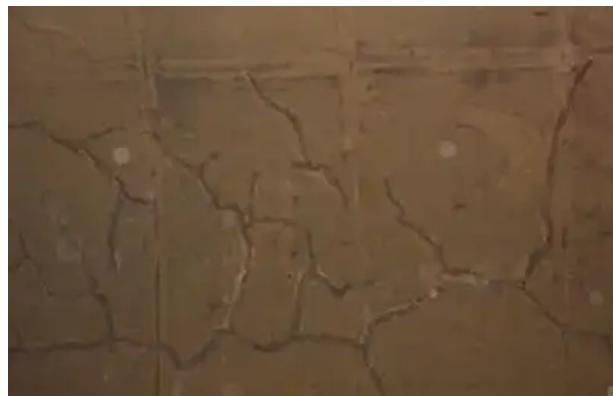
Besides the initial support deformation, under the influence of the landslide, the completed secondary lining exhibited varying degrees of cracking<sup>[3]</sup>. Specifically, the cracking range of the secondary lining in the left tunnel of the Jinfeng Tunnel reached 161 m in length. Some sections showed diagonal and circumferential cracks in the secondary lining, with crack lengths concentrated between 3 m and 6 m and widths typically ranging from 1 mm to 2 mm. The cracking range of the secondary lining in the right tunnel extended up to 215 m, and some sections presented a reticulated pattern of cracks (see **Figure 1**).

**Figure 1.** Reticulated cracks in the secondary lining

In response to the cracking problems in the secondary lining of the left and right tunnels of the Jinfeng Tunnel, the project department and the construction unit have studied and decided to adopt steel strips combined with shotcrete reinforcement for cracks with a width of less than 5 mm in the plain concrete lining. During the construction, steel strips are arranged longitudinally along the outer edge of the lining contour, and C25 concrete is used as the spraying material. For cracks with a width greater than 5 mm and areas with dense networks of cracks in the secondary lining, a three-limb grating combined with shotcrete reinforcement is adopted. Grooves are cut into the original secondary lining surface, followed by the installation of three-limb gratings in a longitudinal direction and the application of 13 cm thick C25 concrete.

- (2) Repair of cracks greater than 5 mm: Repair construction is organized for cracks greater than 5 mm in the secondary lining of the left and right tunnels of the Jinfeng Tunnel.

- (i) Step 1: Surface treatment. Construction workers are arranged to chisel grooves on the surface of the secondary lining, with the width and depth of the grooves flexibly adjusted based on the specific conditions of the cracks, to ensure the smooth embedding of the three-limb grid <sup>[8]</sup>.

- (ii) Step 2: Installation of the three-limb grid. The three-limb grid is arranged longitudinally along the cracks, with strict control of the longitudinal spacing at 1.0 m. During installation, it is necessary to ensure that the grid fits tightly with the chiseled groove and is fixed securely. After installation, steel mesh is hung, ensuring that the steel bars are tightly bonded to the grid.

- (iii) Step 3: Concrete spraying. C25 concrete is used for basin concrete spraying, with strict control of the thickness at 13 cm. During the spraying operation, construction workers are required to pay strict attention to the uniformity of concrete distribution, and no pores or weakened areas should appear. After spraying, technical personnel are arranged to carry out concrete curing strictly following standards.

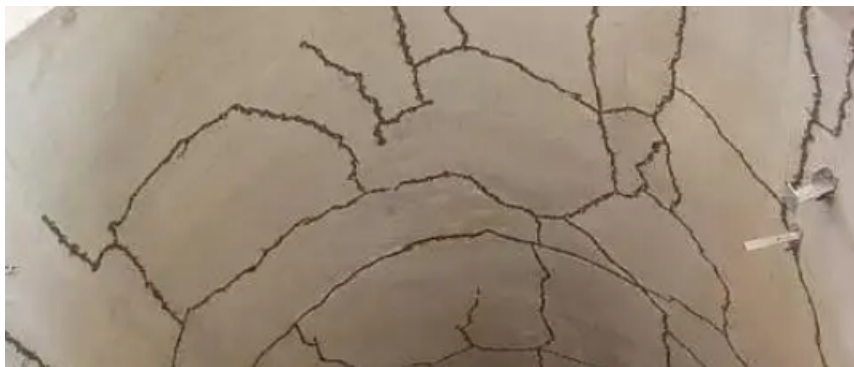
Meanwhile, upon observation, there is a noticeable problem of staggered platforms in the secondary lining. The maximum crack width in some tunnels can reach up to 18 mm, accompanied by a 12 mm wide transverse displacement of the staggered platforms. The cracks have penetrated the entire ring from the secondary lining to the inverted arch. As shown in **Figure 2**.

**Figure 2.** Secondary lining cracking in Jinfeng Tunnel
