# Research on Systematic Investigation and Multi-dimensional Treatment of Tunnel Diseases in the Sichuan-Xizang Highway Tunnel

**Abstract:** In this paper, the typical diseases of 17 tunnels in the Zhubalong to Dongjiu section of the Sichuan-Xizang Highway on the National Highway 318 were systematically investigated and analyzed in depth. The investigation results show that the tunnel diseases mainly include the hollowing out of the foundation of the riverside side of the open-cut tunnel, the leakage of the lining (point, line, surface, and construction joint seepage), the lining cracks, the pavement cracks and seepage, and the blockage of the drainage system. Based on the causes of the disease, this paper proposes a multi-dimensional treatment design scheme covering the hole, lining, pavement, and drainage system. It is verified by field implementation that the proposed treatment measures effectively control the development of the disease, significantly improve the operation status of the tunnel, and achieve good engineering results. This study provides valuable engineering practice experience and reference for the accurate diagnosis and efficient treatment of tunnel diseases und

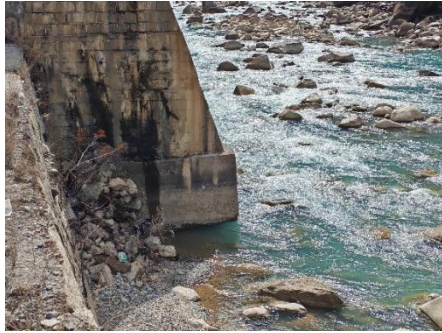
(a) The bottom of the foundation of the portal is hollowed out

In view of the hollowing out of the bottom of the foundation at the riverside side of the open-cut tunnel, the treatment is carried out by adding an anti-scour wall and a block stone lead wire cage.

The specific construction process is as follows: (1) Cofferdam: construction in dry season, 7 m extension along the direction of the river as the cofferdam, using sandbags to fill, height of 1.5 m, select the site sand as filling material; (2) Excavation foundation: after the cofferdam, clean up the bottom of the mud, along the foundation around the deepening of the excavation, the foundation width of 50cm, the depth of the original foundation according to the above 1m, 3m below or into the riverbed at the bottom of the bedrock is not less than 0.5m control. (3) Wall pouring: then use C25 concrete to pour the wall, and backfill the cavity area at the bottom of the foundation of the open-cut tunnel; (4) Lead wire cage enclosure: Finally, a ring of stone lead wire cage enclosure is placed along the outer side of the scouring wall. The size of the lead wire cage is  $1 \times 1 \times 1.5$  m (length  $\times$  width  $\times$  height), the diameter of the wire cage is 6cm, and the diameter of the wire is 2.5 mm, so as to reduce the scouring effect of the river water on the bottom of the scouring wall.

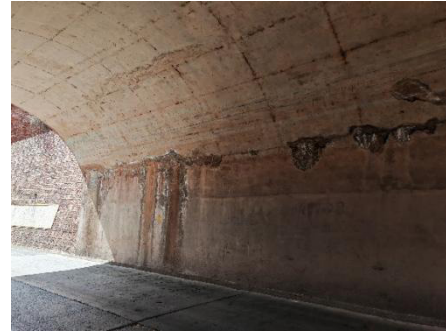
(b) Water seepage marks on the lining surface

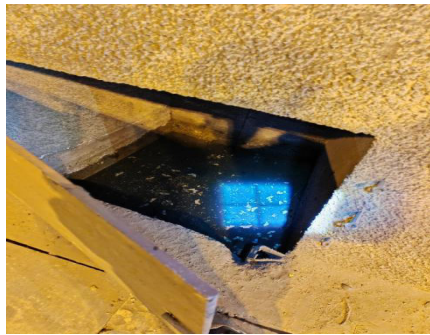
(c) Inspection of well water accumulation

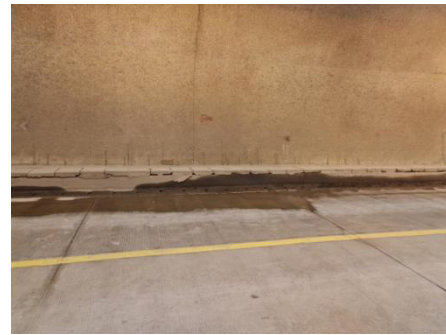
(d) Pavement seepage

In view of the seepage situation of the tunnel pavement, the method of chiseling the buried pipe to introduce seepage into the side ditch is adopted for treatment.

The specific measures are as follows: (1) grooving 20 cm × 31 cm (to the pavement base); (2) DN50 mm drainage pipe is laid at the bottom of the groove, the slope is 2%, and the distance between the bottom of the pipe and the bottom of the side ditch is not less than 5 cm; (3) gravel cover, wrapped seepage geotextile anti-blocking, above the  $\Phi 6$  mm steel mesh (spacing 5 cm×5 cm, width 20 cm); (4) Drilling  $\phi 50$  mm connected side ditch at the side ditch; (5) C35 concrete to restore the road. The design of pavement seepage treatment is shown in **Figure 7**.
