A Review on the Post-Earthquake Emergency Conservation Project of Fulong Taoist Temple

Keywords: Post-earthquake emergency; Heritage conservation project; Fulong Taoist Temple

Table 1. Details of the post-earthquake emergency conservation project of Fulong Taoist Temple

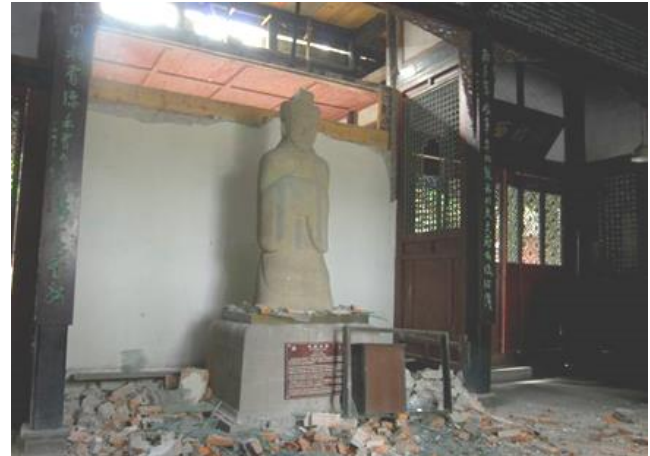
Figure 6. Interior of the first floor of Laowang Hall after the earthquake

- (1) Principle of authenticity
 - (a) Preserve the physical carrier of historical information (**Figure 6**)
 - (b) Retain the authenticity in the cultural and emotional values of Fulong Taoist Temple

- (2) Laowang Hall used to be an exhibition room for the public, and the separations of each end were adapted to storage rooms of two stories high. Before the earthquake, it was dangerous to use the temporary staircases to go up and down. Through this restoration, the wooden staircases were rebuilt following the traditional technique. This solution does not add any more load on the original structure, but rather coheres with the original timber structure.

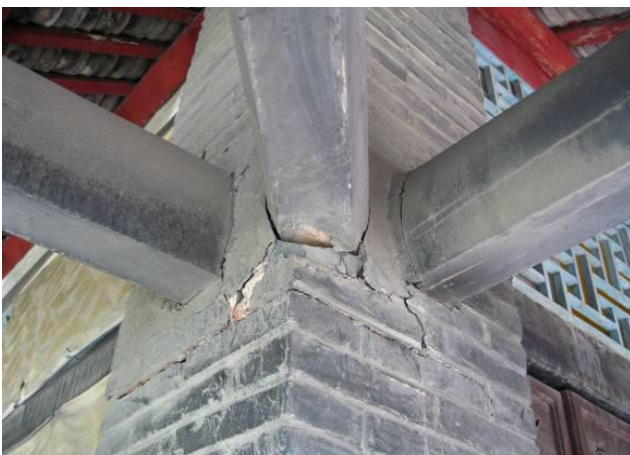
(a) Preserve the original architectural space and building form based on the site plan before the earthquake (**Figure 7**)

Figure 7. Cracks seen on the brick column of Yuhuang Hall after the earthquake

Yuhuang Hall was rebuilt in the 50s of the last century. The connections between the masonry columns and the concrete floor panel were enhanced by I-beams in 2002. After the earthquake, vertical cracks were found in almost every masonry column, indicating that the building had lost its load bearing capacity. Given that Yuhuang Hall was not designated as a historical building and had been used for nearly 50 years, its style and image had become part of the overall building image as well as a part of public memory. Therefore, it had been decided that Yuhuang Hall should be restored to its original form, preserving its appearance carefully, which includes its windows, doors, and decorations. However, the interior structure was changed to traditional timber, which showed better anti-seismic performance.

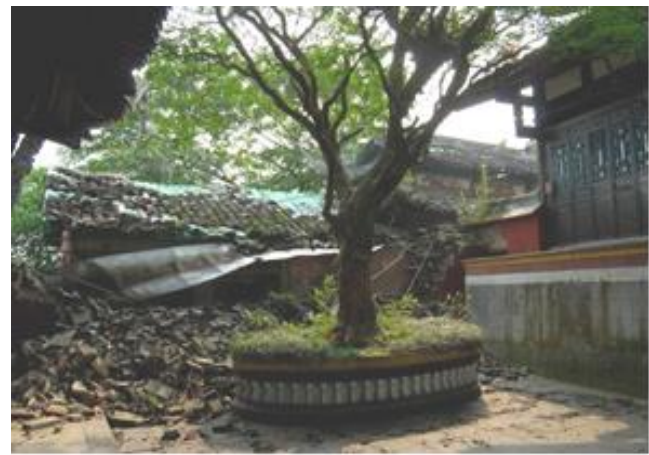
Figure 8. Front yard of Tiefo Hall after the earthquake

All the geological or foundation consolidations should not alter the historical environment, including the site landscape, the pavement of the yard, and the plantings (**Figure 8**)

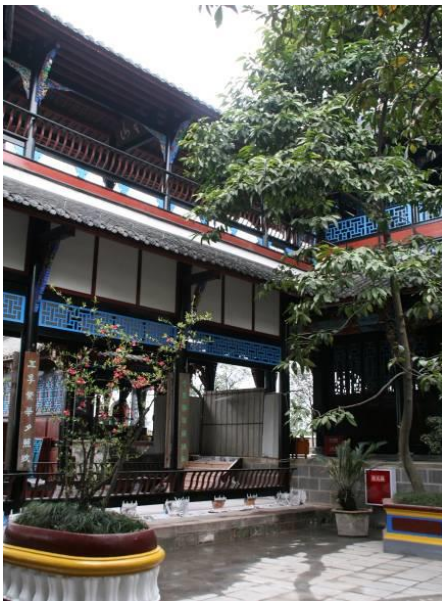
Figure 9. Eastern corridor after the conservation

The eastern and western overlaid corridors and Yuhuang Hall, which were linked to each other, were both timber structures built in last 50s. In view of the inappropriate design of that time, the end of the eastern corridor was inserted into the roof of Tiefo Hall, which damaged the roof structure. During the conservation, the structures of the two corridors were restored after carefully studying their original dimensions. The form and style of the two corridors were maintained, while the staircases at the ends of the corridors made it more convenient to walk up and down (**Figure 9**).

- (1) Part of the eastern corridor structure inserted into the roof of Tiefu Hall, which damaged the integrity and stability of the original timber structure, caused significant damage to Tiefu Hall during the earthquake. In this conservation project, the eastern corridor structure was restored according to its disassembled components, the historical information left on the joints of other wooden members, and the timber structure of the western side of the corridor. After the restoration, the eastern timber system regained its structural wholeness, thus guaranteeing the safety of the building.

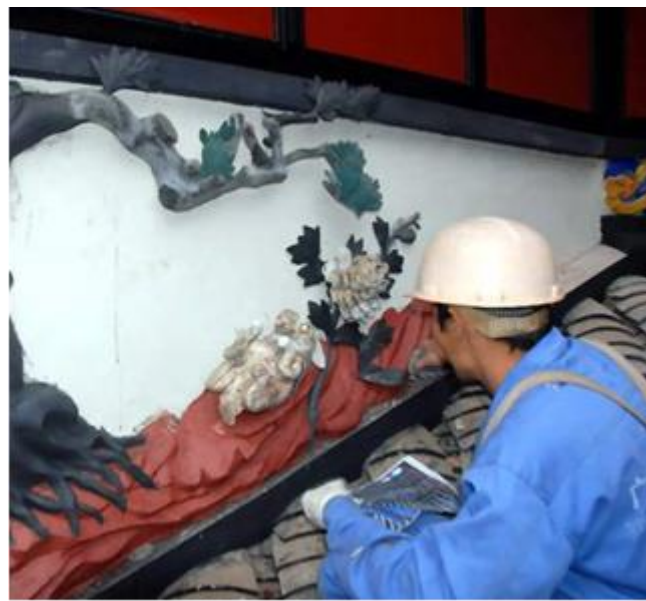
Figure 10. Conservation of decorations on the roof ridge

The decorations on the roof ridge of Fulong Taoist Temple were lively and interesting. The themes were based on local community patterns, including fishes, float grass, Chinese dragons, and characters in mythologies. These decorations were made from cement, grass, and clay materials by local craftsmen. Unfortunately, these decorations, which represent the strong characteristics of traditional craftsmen, were severely damaged by the earthquake. For the conservation, all the fragmented decorations were first collected. Restorations were made to those decorations that had slight damage, while those badly damaged were dismantled and recast by local experienced craftsmen following the local tradition of plaster casting. For those pieces that were lost, the decorations were reproduced by referring to old photos. Since rain occurs frequent in that area, the original paintings on the decorations had faded; hence repainting was also done but strictly only on the missing color parts, while ensuring they had the same color as the original ones (Figure 10).
