The Application of On-Site Analysis and Detection Technologies in the Conservation and Restoration of Polychrome Cliff Carvings

Abstract: Scientific analysis and testing of cultural relics are often carried out during the design phase prior to restoration, serving as the foundation for subsequent conservation treatment. Given the diversity and complexity of cultural relics, uncertainties are often present at all stages of conservation and restoration, making on-site analysis and testing at the conservation site highly significant for guiding protection and treatment. This paper, focusing on on-site conservation work for polychrome cliff carvings, discusses the application scenarios of several relatively simple and practical analysis and testing instruments—such as infrared thermal imagers, Leeb hardness testers, and spectrophotometers—at conservation and restoration sites.

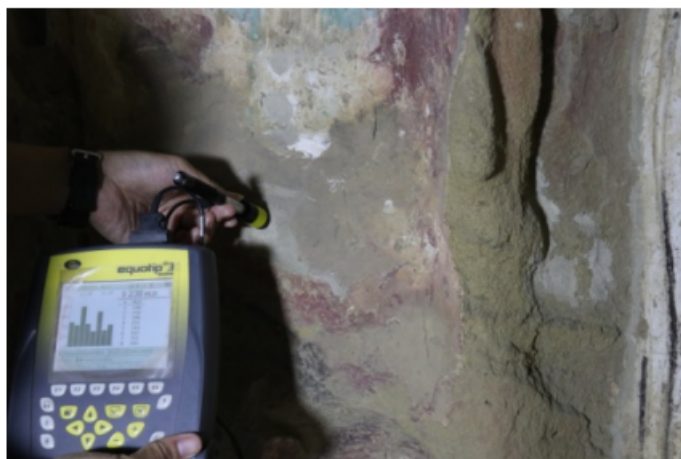
After rock consolidation, the portable Leeb hardness tester is used again to measure the surface hardness (**Figure 2**). The hardness of the area is taken as the average of multiple test points—generally, 20 points are randomly selected within the area to be measured, and the instrument automatically calculates the average value. If the test area is small, it is sufficient to take the average of the measurements directly ^[8]. The test data can verify whether the consolidation effect meets the design standard, and should correspond with the results of earlier laboratory and on-site tests, while also confirming that each consolidated area meets the requirements. The detection data should be recorded in the relevant restoration documentation.

Figure 2. Testing the surface hardness of rock with a portable Leeb hardness tester

Although the portable Leeb hardness tester causes only a minor impact on the sample, the probe tip may still leave marks when pressed against the surface; therefore, it should not be used on polychrome surfaces^[9]. Attention should also be paid to the routine cleaning of the probe tip to avoid contaminating the cultural relics it touches.

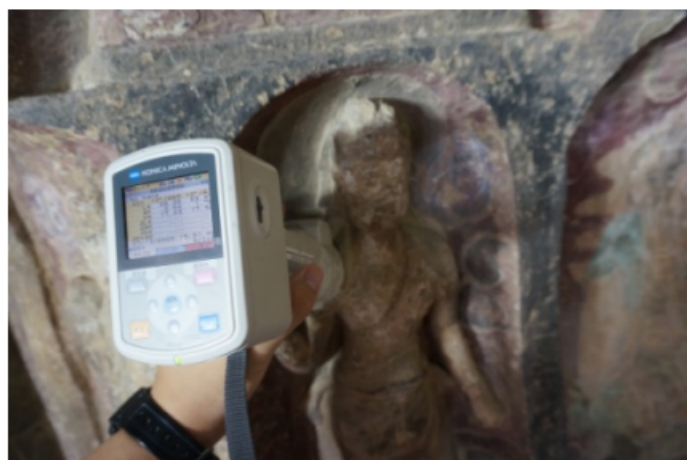
After pigment consolidation, the main concern is color change, including glossiness and brightness variations. Although the safety and effectiveness of the consolidation material have already been verified during preliminary experiments in the design phase, data collected on-site provide a more accurate assessment of the actual protection effect. Once the pigment consolidation material has fully stabilized, the spectrophotometer is used again to test the same points measured after dust removal (**Figure 3**)^[10]. The results are recorded in the restoration documentation, and the two sets of data can be quantitatively and visually compared.

Figure 3. Detecting the color of the polychrome surface with a spectrophotometer
