An Evaluation of Standards in Open Spaces for Mobility Impaired Users: The Example of Istanbul's Çirpici Community Gardens

Publication date: October, 2019

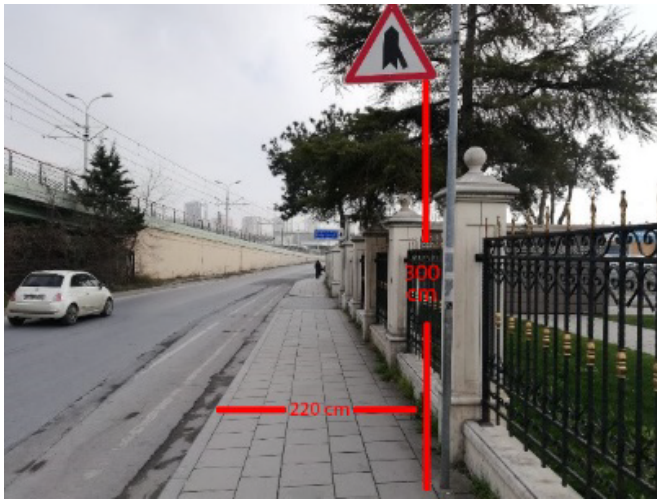
Figure 8. Zone 1, pavement around the gardens 3 (Photo 5)

According to the standards, the height of any branches overhanging the edge of the pavement, thorny plants or signboards must be at least 220 cm. In the area under study, no thorny plants were used along pavements. Traffic signs at the edges of pavements were found to be at a height of 300 cm (Figure 8). As such, the pavements around Zone 1 of the gardens were found to comply with the standards and be suitable for wheelchair users (Figures 5-8).

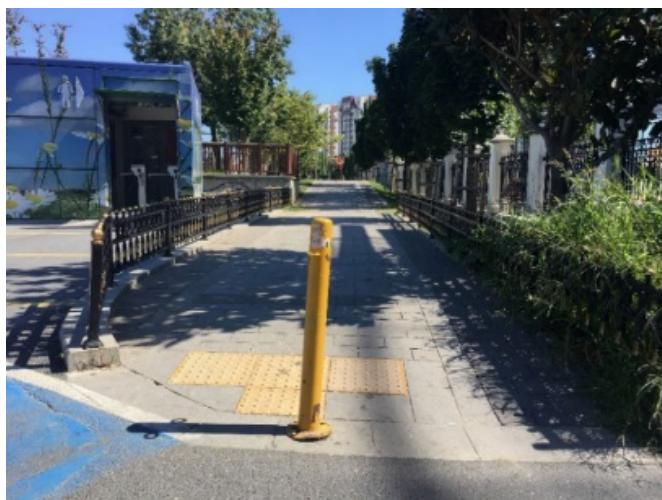
Figure 12. Zone 1, pavement ramp within the gardens (Photo 9)

Considering the general features of ramps, measurements were made of the ramp slope in three-directions at the edge of the pavement and at the meeting point with the carriageway. The ramp slopes were generally 5%, and the ramp slope suitable for

wheelchair users; ramp width was not less than 200 cm. There were no bumps or depressions at the points where the pavement connected to the roadway.

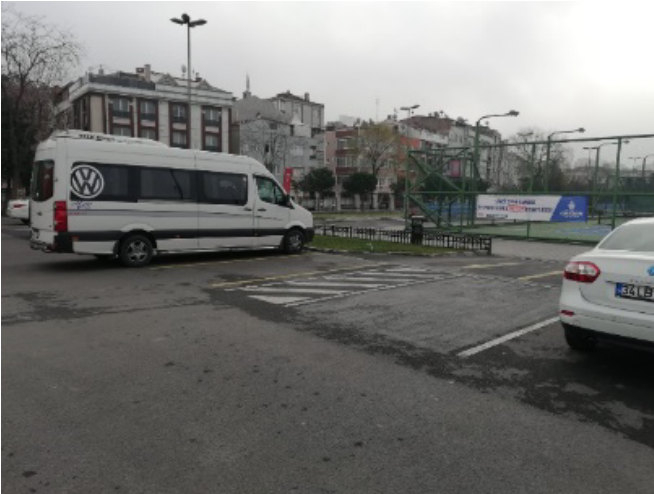
Figure 17. Zone 1, disabled parking area 2 (Photo 14)

Regarding the suitability of the parking areas for disabled users, the elevation level was +3.00 cm, the width of the parking space 390cm, and the gap between parking spaces 120cm to allow for wheelchairs. Disabled parking signs have been made on the ground. Considering the standards, these conditions are suitable for wheelchair users (Figure 16).

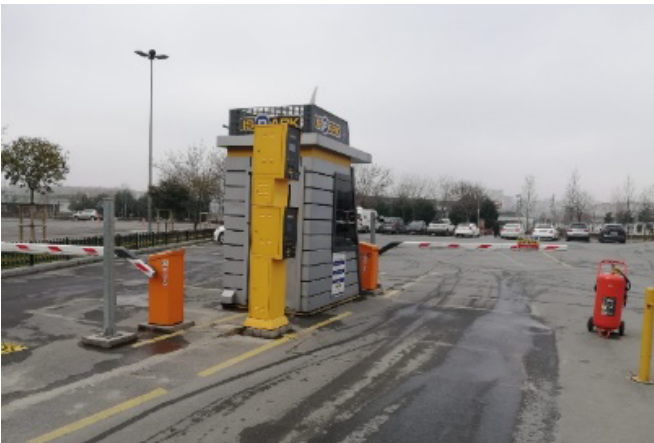
Figure 18. Zone 1, entrance to parking area (Photo 15)

The entrance to the parking area does not pose a problem for wheelchair users, and the space for getting tickets is also suitable (Figure 18). Within the parking area indications of direction are inadequate; are no existing signboards to guide disabled users. The 2% slope to get to the pavement from the parking area is suitable for wheelchairs. No special space has been set aside for disabled users to access the carriageway. It was observed that in the car park, there is an insufficient number of disabled parking spaces (Figure 19).

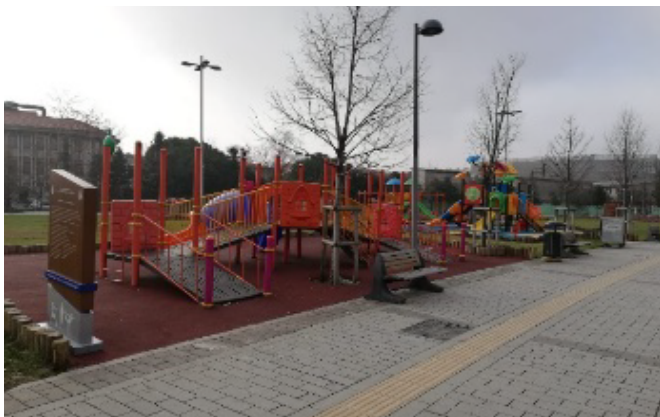
Figure 25. Zone 1, children's playground with ramp 6 (Photo 22)

Figure 25 shows that the ramp for the children's group play area is suitable for wheelchair users. In this area, there is no common equipment or space that can be used equally and is appealing to all users.

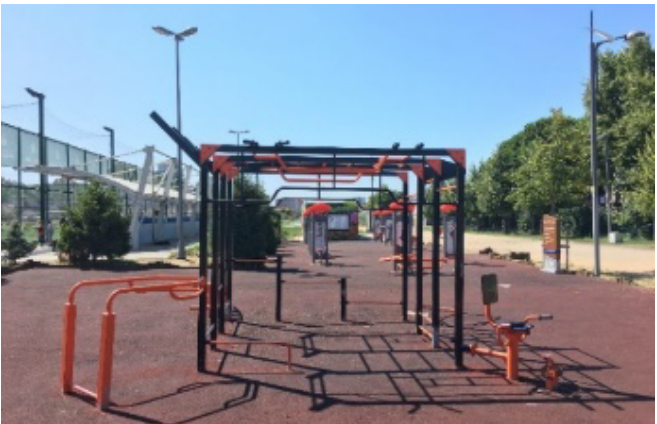
Figure 30. Zone 1, exercise area 4 (Photo 26)

Figure 30 shows exercise equipment and a sports space in which disabled users can challenge themselves, and benefit from working their hand and arm muscles to strengthen them.

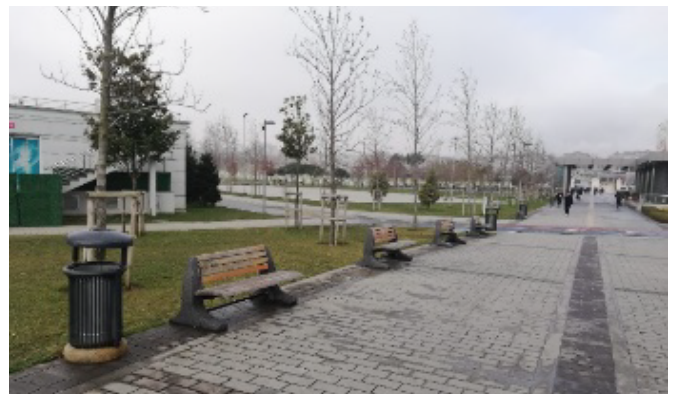
Figure 34. Zone 1, benches and trash cans (Photo 30)

In this zone, as regards the street furniture, the seating area has a space of 1.20 x 1.20m which is suitable for accommodating wheelchair users. The height of the opening of the trash can from the ground is 100cm. The trash can is at the same level as the pedestrian road, and the location is accessible. The benches and trash cans are suitable for disabled users (Figure 34, 35).

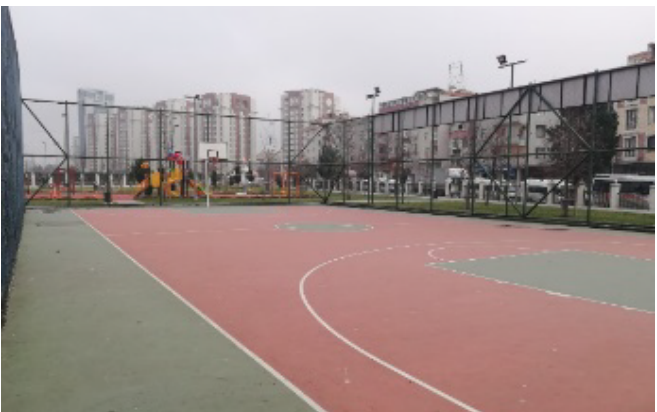
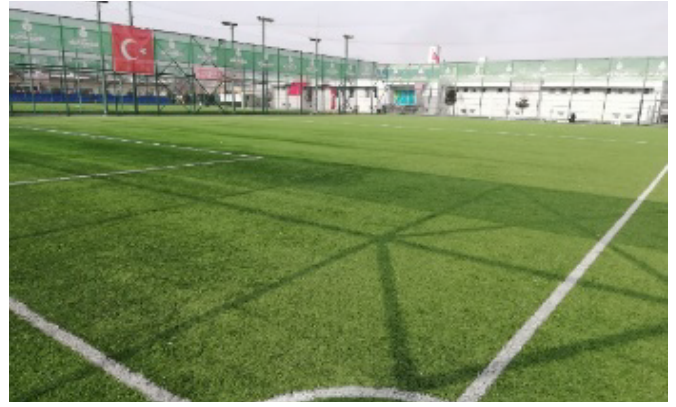
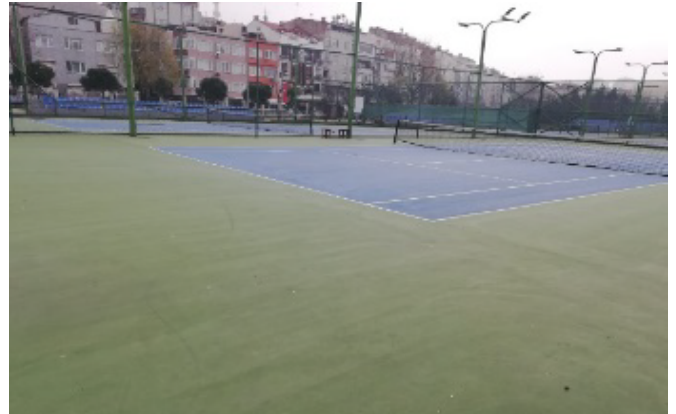
Figures 31-33 show the paving material used in the sports areas, which is suitable for wheelchair users.

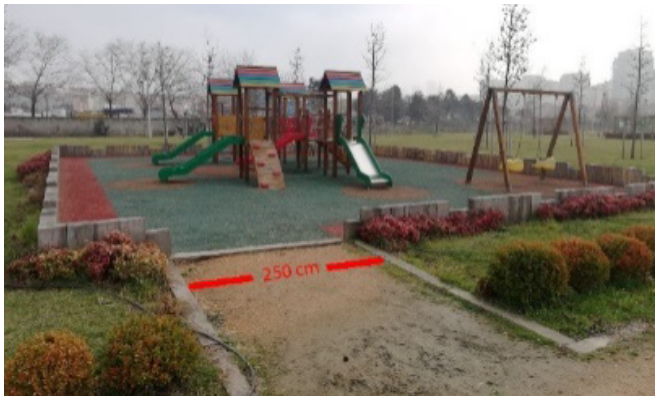
Figure 50. Zone 2, ramp (Photo 7)

Figure 50 shows the entrance ramp to the children's play area. The ramp is 250 cm in width, with a cross slope of 2% and a longitudinal slope of 4%. The ramp is suitable for use by wheelchair users.

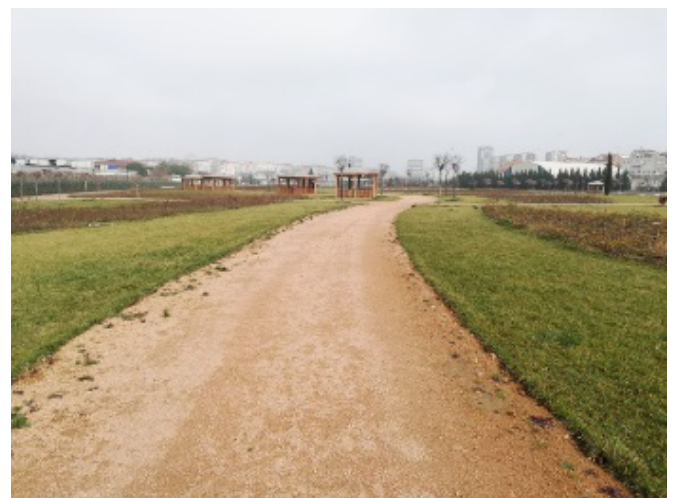
Figure 62. Zone 3, sloping pedestrian road (Photo 2)

The sloping pedestrian road shown in Figure 61 has a width of 300cm, and is suitable for two wheelchair users to pass one other. The ramp slope is 2%; and it is suitable for use by everyone. Between the planted area and the pedestrian walkway there is no separating element. Soil has been used as the ground surfacing material. While this may appear suitable from an aesthetic perspective, in the course of time, bumps and depressions will develop, creating potential danger for mobility impaired individuals.

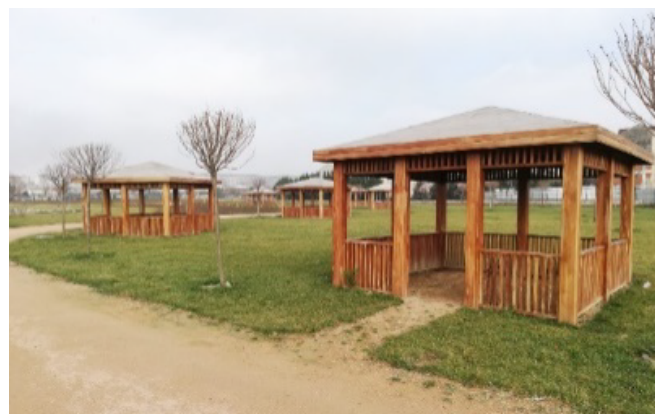
Figure 65. Zone 3, overhead protective elements (Photo 5)

The overhead protective elements used here were observed to provide suitable protection from poor weather conditions and the sun. They are easy to use and provide opportunities for rest to mobility impaired users (Figure 65). According to the standards, the height of openings of trash containers from the ground must be 90-120cm. As Figure 66 shows, in Zone 3 trash dumpsters are used in place of trash cans, and these are unsuitable according to disability standards. In terms of measurements, they are suitable for wheelchair users, but from the point of view of usage and ergonomics they are unsuitable.
