# Analysis of Damage Pattern of Road Bridge Landslide in Mountainous Area

**Abstract:** Through on-site defect investigation, special inspection, and finite element simulation calculation of a high-speed upper-span (30 + 32 + 30) m prestressed concrete box girder bridge, the overall sliding force of the bridge on the right side of platform 0# is analyzed. In this situation, typical defects such as overall girder slippage, support dislocation, pier column deviation, and pier bottom side cracks have occurred in the overpass. At the same time, combined with simulation calculation analysis, it is interpreted that the 0# and 1# foundation has been damaged at a certain position below the ground line. The occurrence of broken piles has provided a reliable basis for the later reinforcement and maintenance of the bridge and ideas for emergency inspection and analysis of bridges damaged by the same type of landslides.

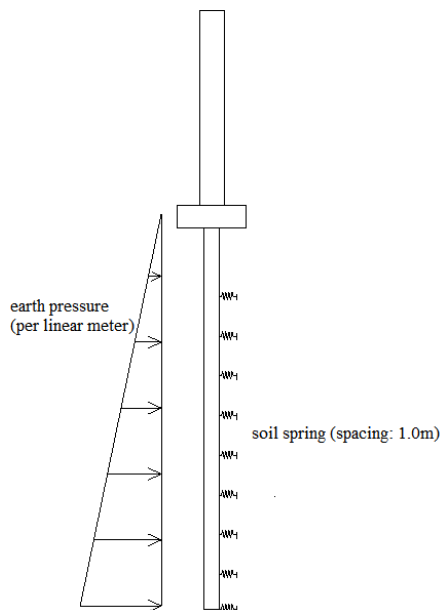
**Figure 11.** Schematic diagram of structural force analysis

Due to the side slope slip of the 0# and 1# pier of the bridge, the soil produces longitudinal earth pressure on the main girder, 0# abutment, 1# pier cap, etc., which, eventually, the main girder, 0# abutment,

1# pier and pile foundation will be greatly deviated. The range of earth pressure load is from the surface to the base. The force point with the bridge structure is the 0# platform and the 1# pier cap (direct contact point with the slope). The friction force of the support is applied to the pad stone position of the support on the top surface of the cover beam in the form of concentrated force. The direction of action can be judged according to the offset between the support and the main beam, and the size can be determined comprehensively according to the reaction force of the support and the coefficient of friction. The m method is used to simulate the interaction between piles, soil, and bedrock [4], and the overall model of the whole bridge, the 0# platform and pile foundation, the 1# pier and pile foundation local calculation and analysis models are established respectively. Schematic diagram of structural force analysis is shown in **Figure 11**.

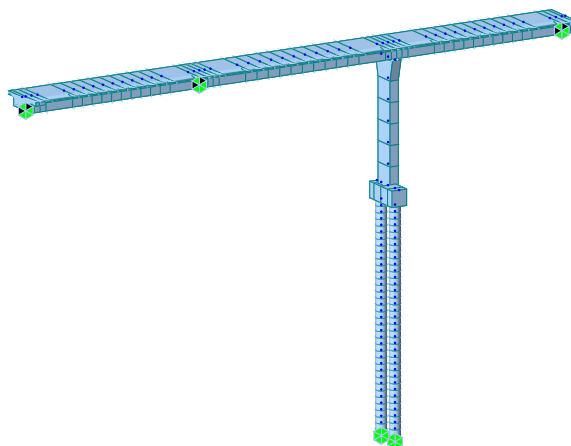
**Figure 12.** Calculation model of 2bridge

Using Midas finite element software, the overall calculation model, 0# pile foundation calculation model, and 1# pile foundation calculation model were respectively established for structural simulation analysis and calculation. The calculation model of the whole bridge (mainly used to calculate the reaction force of the structural support and the overall displacement of the beam) is shown **Figure 12**.
