# A Study on the Stability of Tailings Pond Based on Plastic Displacement and Safety Factor

**Abstract:** The displacement deformation of tailings ponds serves as important early warning indicators for its instability, and accurately identifying plastic displacement is crucial for establishing a safety early warning system for tailings ponds. This study proposes a method for identifying plastic displacement in tailings ponds, systematically analyzes the variation pattern of plastic displacement with applied loads, and establishes the relationship between plastic displacement and the safety factor. The results indicate that the dam body is in the elastic deformation stage during the initial loading period. As the load increases, it enters the plastic deformation stage, and upon reaching the breaking load, the plastic displacement increases sharply. The maximum plastic displacements are 55.986 mm, 49.009 mm, and 44.197 mm, occurring at the sliding arc of the dam body. Furthermore, the safety factor exhibits a nonlinear inverse relationship with plastic displacement: the lower the safety factor, the greater the plastic displacement. Particularly when the safety factor drops below 1,

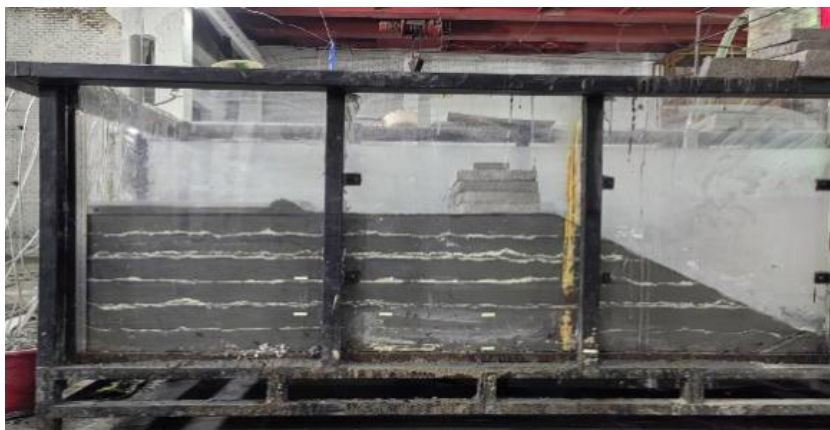
**Figure 1.** Schematic of lime layering and loading process.

During the experiment, pore pressure gauges were embedded in the tailings dam, and water was added to maintain a constant water level on the deposition beach, while the dam body was allowed to reach a steady-state seepage field. When constructing the tailings dam, lime was placed in layers to facilitate observation of dam deformation and arc formation. Subsequently, stepwise loading was applied at designated locations and when the readings from the pore pressure gauges remained constant, it indicated that the deformation induced by the current loading increment had been completed. After each loading, the dam body was scanned using a three-dimensional laser scanner with millimeter-level accuracy. The data before and after scanning were imported into post-processing software for analysis. Specifically, using the matching function of the post-processing software, the scanned data of the dam before and after loading were registered, and the coordinates of the same points before and after the load were extracted to obtain the displacement data of the tailings dam. The lime placement and loading process are shown in **Figure 1**. This experiment was divided into three groups. The initial dam slopes both inside and outside the tailings dam were 1:1.5. The dams in the three groups were 1:1.5, 1:2, and 1:2.5, respectively. The experimental conditions are detailed in **Table 2**.

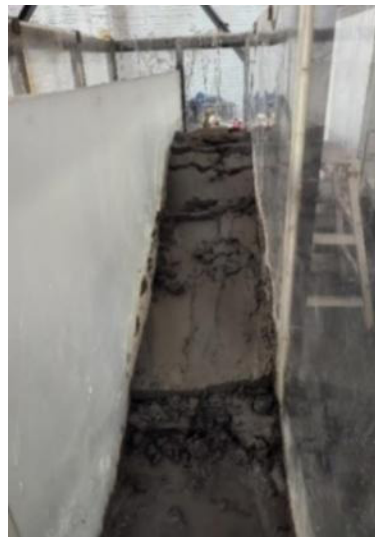
(a) Front view of tailings dam failure

**Figure 4.** Tailings dam failure diagram.

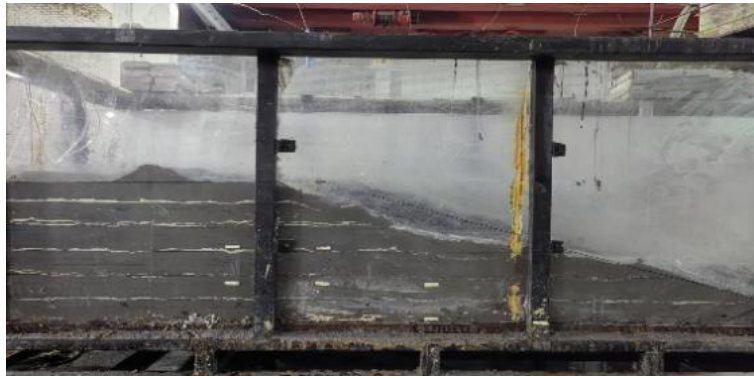
(b) Side view of tailings dam failure

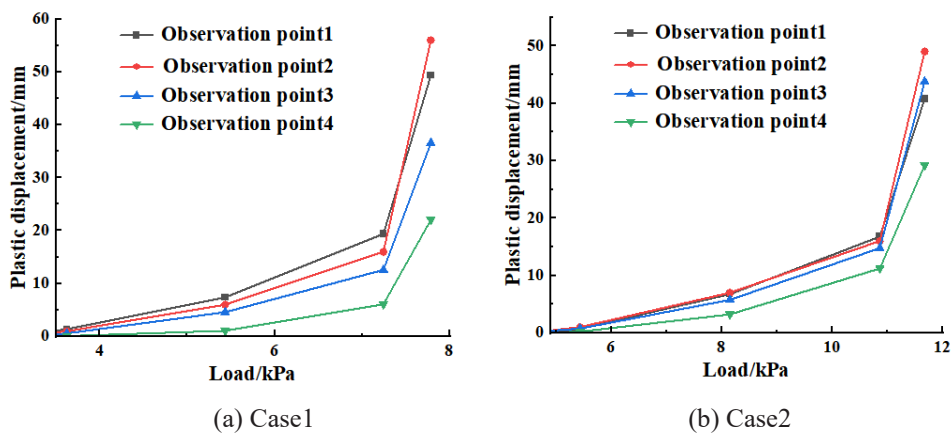
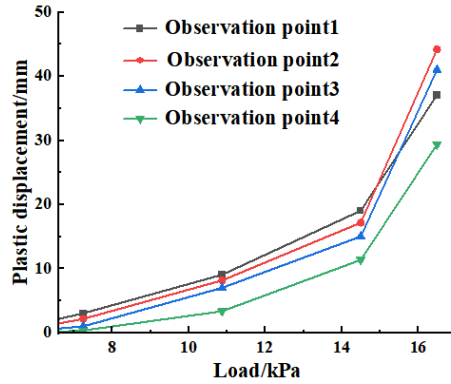
(c) Case3

Figure 6. Relationship between plastic displacement and load.

Based on the experimental data, the relationship curves between plastic displacement and uniformly distributed load are shown in **Figure 6**. It can be observed from **Figure 6** that during the first stage of loading, the dam body experienced slight deformation and remained within the elastic range. In the second stage of loading, the total displacement exceeded the elastic displacement, and the tailings dam entered the plastic deformation stage. Among the selected monitoring points, only points 1 and 2 reached a plastic displacement of 1 mm, indicating still relatively small displacements. In the third stage of loading, as loading continued, the plastic displacement further increased, and signs of sliding began to appear in the middle and upper parts of the dam body. In the fourth stage of loading, the maximum plastic displacements under

different working conditions increased to 19.38 mm, 16.76 mm, and 19.06 mm, respectively. By observing the displacement variations at these monitoring points, it is evident that Points 1 and 2 exhibited larger displacements, indicating that these have the most severe failure tendencies and could become the main weak points for sliding and instability of the tailings dam, with dam sliding failure gradually forming. In the final stage of loading, when the load reached the failure load, the tailings dam suddenly failed, and the plastic displacement increased sharply, with the maximum plastic displacement occurring at point 2. Using the laid lime, it was observed that the sliding arc and the most severely damaged area of the tailings dam were located around Point 2, where the surrounding region experienced significant plastic deformation. Compared with point 2, the plastic displacement at point 4 is smaller, which verifies the sliding characteristics of the dam failure, that is, sliding from the upper to the lower part, ultimately leading to the complete instability of the tailings dam.

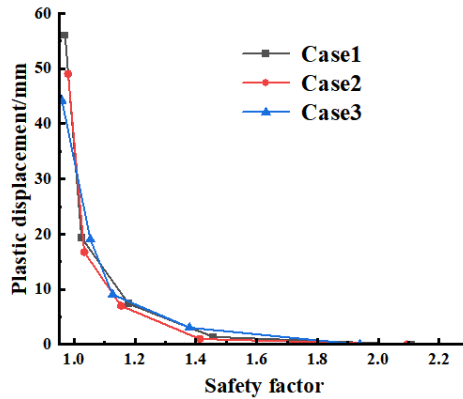
**Figure 7.** Relationship diagram between safety factor and plastic displacement.

By selecting the maximum plastic displacement values under different load conditions for each working condition, and calculating the corresponding safety factors with finite element analysis, the relationship between plastic displacement and safety factor was established, as shown in **Figure 7**. It can be observed from **Figure 7** that the safety factor and plastic displacement exhibit an inverse relationship, and the variation is nonlinear. The safety factor decreases as the plastic displacement increases. When the safety factor is 1.458, the maximum plastic displacement is 1.378 mm. When the safety factor decreases to 1.179, 1.024, and 0.97, the plastic displacement increases to 7.378 mm, 19.378 mm, and 55.986 mm, respectively. Moreover, when the plastic displacement is small, the safety factor decreases rapidly. And when the plastic displacement is small, the safety factor decreases rapidly. As the safety factor approaches 1, the rate of decrease slows down, but the plastic displacement increases significantly. In particular, when the safety factor falls below 1, the plastic displacement increases sharply. The maximum plastic displacements under working conditions 1, 2, and 3 are 55.986 mm, 49.009 mm, and 44.197 mm, respectively, ultimately leading to the failure of the tailings dam. The tailings dam is mainly composed of fine tailings sand. Under external loads, the stress-strain relationship of the fine tailings sand exhibits significant nonlinear characteristics. Especially near the failure state, the strength of the material decreases, resulting in a rapid increase in plastic displacement. This nonlinear mechanical behavior is the fundamental reason why the safety factor decreases as plastic displacement increases. As the load continues to increase, the plastic deformation inside the tailings dam accumulates continuously, causing the shear strength of the material to gradually degrade. In the stage of small plastic displacement, the shear strength degrades relatively slowly, and the safety factor decreases rapidly; however, as plastic displacement further increases, the degradation of shear strength accelerates, the decreasing trend of the safety factor slows down, but the increase in plastic displacement becomes significantly larger. Particularly when the safety factor is close to or below 1, the strength of the tailings dam is approaching or has reached its limit state, and the plastic displacement increases dramatically, eventually triggering instability and failure of the dam body. This phenomenon indicates that the failure of the tailings dam often occurs when the safety factor is close to or below 1. At this stage, although the change in safety factor slows down, the deformation of the dam body intensifies significantly, ultimately leading to the instability and failure of the tailings dam. This analysis provides important theoretical support for the stability

assessment and design of tailings dams. An empirical formula can be fitted based on **Figure 7**.

$$y = 32.108x^{-8.35} \quad (1)$$
