# Study on the Geohazard Distribution Laws and Hazard-Causing Mechanism in Menghai County of Yunnan Province

**Abstract:** The study area is located at the southwest border of Yunnan Province and the southward extended part of Nushan Mountain, with complex and fragile geo-environmental conditions. Deep geological survey and mathematical analytical investigation on the geohazard distribution and hazard-causing mechanisms in this area were carried out in this study. The results revealed that: (1) The development of geohazards was affected differently by different slope shapes, slope structures and elevations; (2) Most of the geohazards were developed in medium shallow cut ridge-like medium-height mountainous geomorphological region and shallow cut steamed bun-like low and medium-height mountainous geomorphological region, and they were relatively concentrated on tectonic zones like fault zones; (3) The slopes formed by loose earth piling up on the surface of Indo-Chinese magmatic rock and Lancang Group metamorphic rock formations were most prone to slope instability and even landslide. The deep study on the geohazard distribution and hazard-causing mechanisms can provide geoscientif

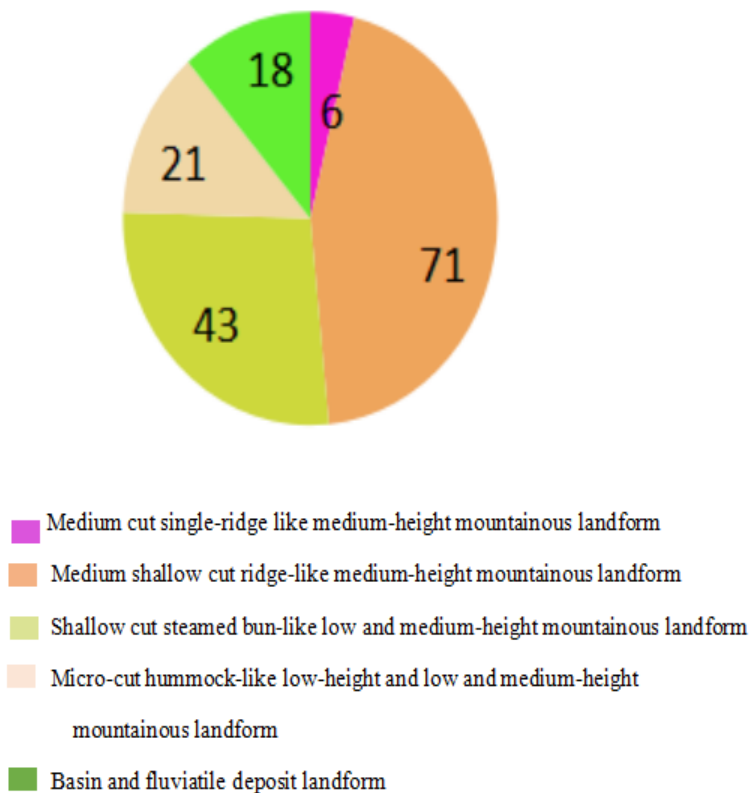
**Figure 1.** Numbers of geohazards developed in different geomorphological regions

geomorphological region and 43 ones occur in shallow cut steamed bun-like low and medium-height mountainous geomorphological region, while others are sporadically distributed in other geomorphological regions (**Figure 1.** and **Figure 2.**), and the geohazard development density is the maximum in the medium shallow cut ridge-like medium-height mountainous geomorphological region. Hence, the topographic and landform features provide advantageous spatial conditions for the generation of geohazards and decide the necessity of geohazard development.

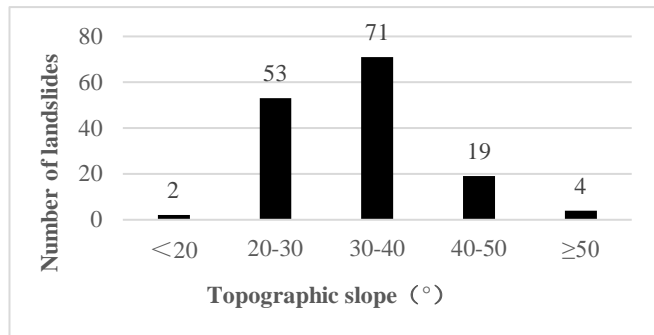
**Figure 3:** Statistical Graph of Landslide Development at Different Slopes

Most of the 149 landslides analyzed in this study take place within the topographic slope of 20-40°, where there are totally 124 landslide points, accounting for 83.22% of total number of landslides (as shown in **Figure 3.**). Among the nine debris flows, there is only one slope surface-type debris flow, while the other eight ones belong to gully-type debris flows, which are all developed within the average longitudinal slope of 100-300‰ of main gully. Hence, the topographic slope has a great bearing on the generation of landslide and collapse, and the landslide distribution in the study area is obviously controlled by the topographic slope.

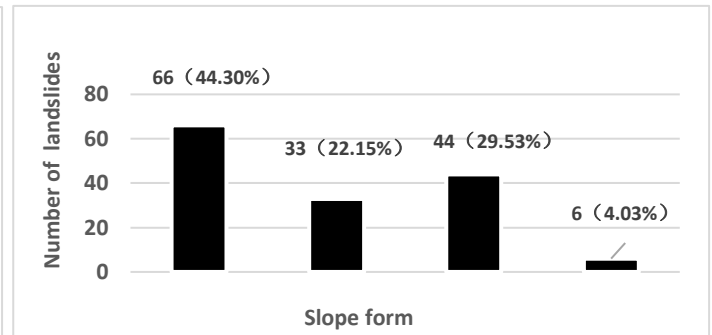
**Figure 4:** Statistical Graph of Landslide Development with Different Slope Forms

In the study area, the slope forms are divided into concave slope, straight slope, convex slope and step slope according to the different micro-landforms formed at adaptive crust uplift speed and undercut speed of hydrological network. Among the 149 landslides developed in the study area, 66 ones are generated in concave slopes, accounting for 44.30%; 44 ones in straight slopes (29.53%); 33 ones in convex slopes (22.15%); six ones in step slopes (4.03%) (as shown in **Figure 4.**). Besides, it is worth mentioning that
